**Triple Combination Pumper
In-Service Inspection (Sample)**

**Any Town Fire Department
Any Town, U.S.A.**

Engine 1

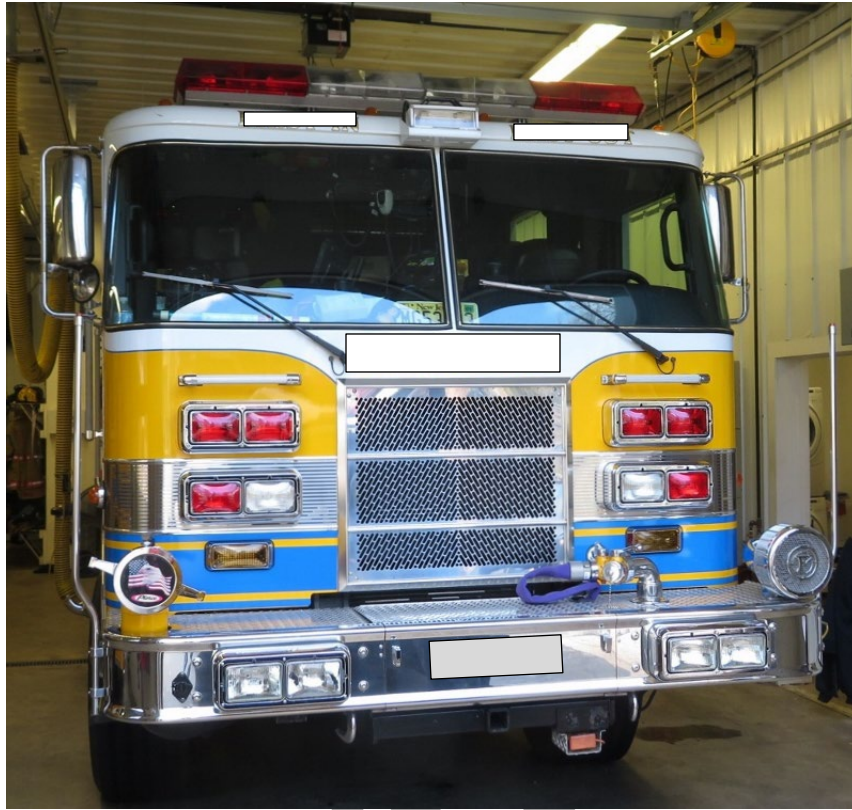
Figure 1

2002 Blaze Fighter
Manufactured December 2002
VIN #: 1BFTCP23456789876
Registration #: 87654

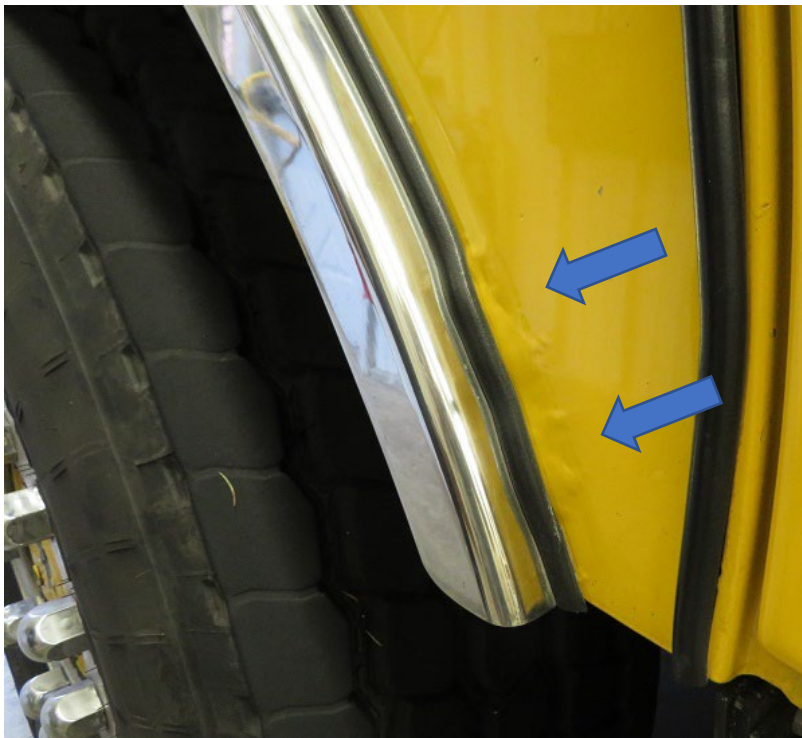
Figure 2

Inspection of this vehicle indicates that it is in overall fair condition. The apparatus cab and compartment body are in good condition cosmetically and appear to be in good condition structurally. There is some “white” rust beginning to form, which is an aluminum deterioration caused by atmospheric conditions similar to what causes steel to rust, figures 2 & 3.

This type of deterioration was seen at various locations around the cab and body assemblies. This includes but is not limited to; wheel wells, compartment door hinges mounting for grab handles and light fixtures.

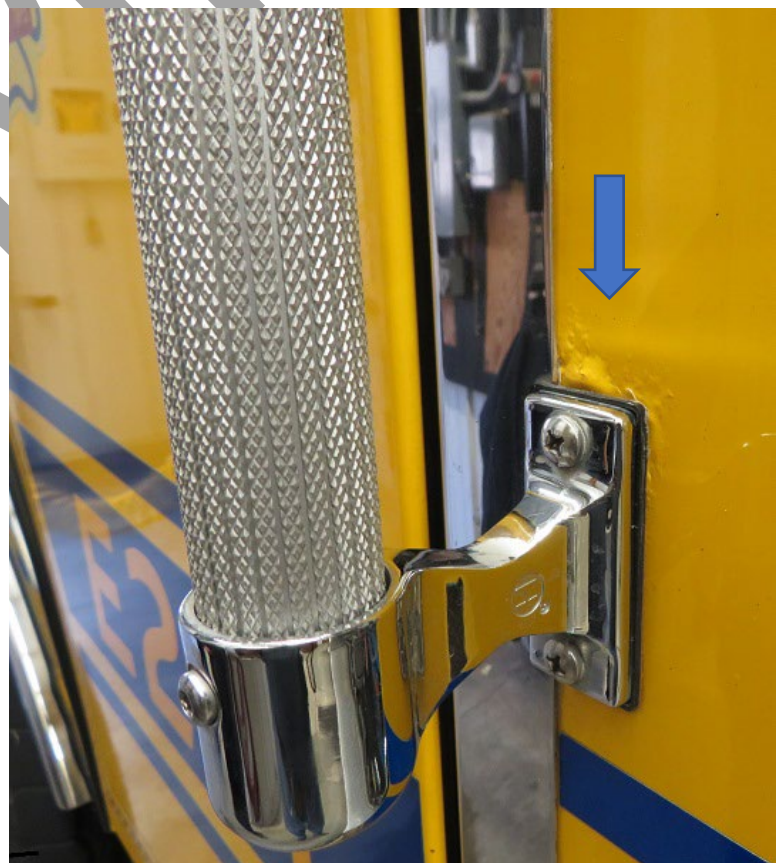
Figure 3

White rust is most often caused by a process referred to as electrolysis and reaction when two dissimilar metals come into contact with each other, as an example when stainless steel bolts are used to mount accessories on an aluminum truck body. There are chemical coatings available and some physical barriers that greatly reduce and, in some cases, eliminate this condition. While white rust is generally not as severe as rust in steel, it spreads quickly causing more cosmetic damage than structural damage to the vehicle. However, white rust can and in some case does cause structural damage which does not appear to be an issue on this apparatus at this time.

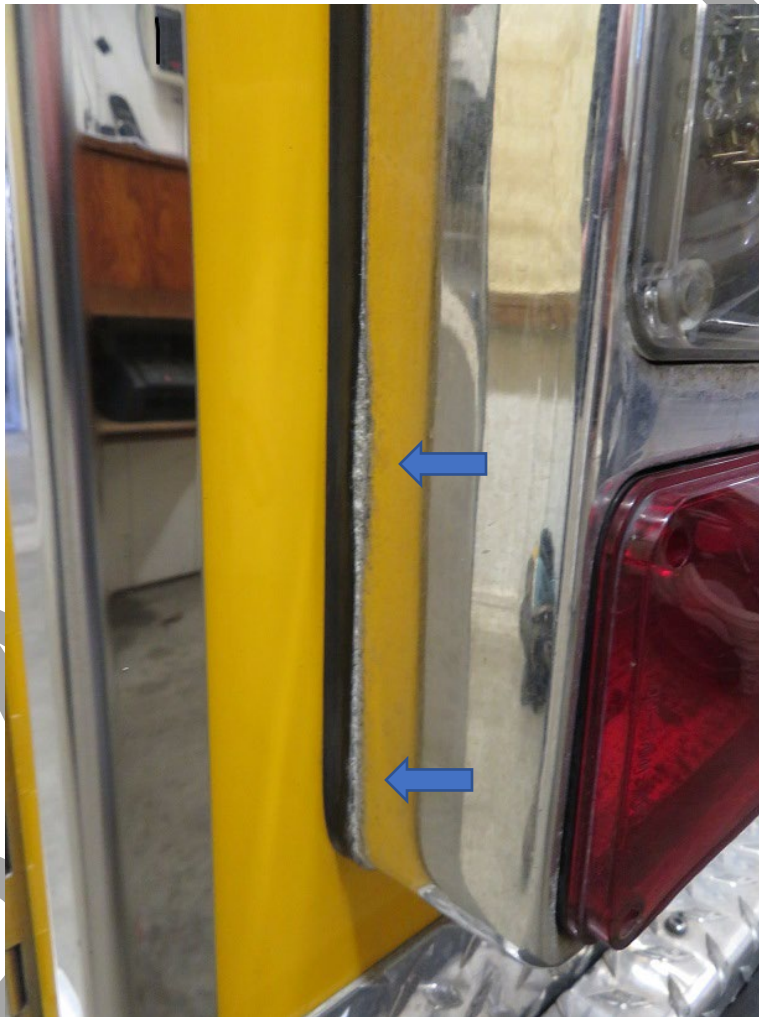
Figure 4

What is more troubling on Engine 1 is what was discovered reviewing the history of this vehicle and one observation on the rear of the apparatus. The Cast 4 housing, which contains the brake lights, turn signals, and reverse lights, on the rear of the apparatus shows a long line of white rust along is mount gasket, figure 4. I have never seen this condition before.

Since both the paint on the apparatus body and the gasket around the base of the light housing are both adequate isolation barriers this condition is the first indication that there is more going on than simple electrolysis.

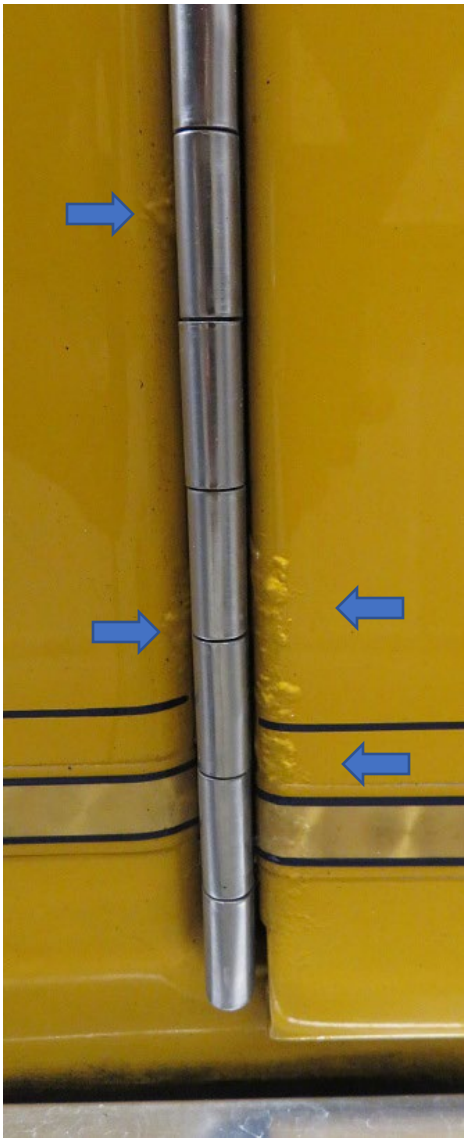
Figure 5

There is also some paint bubbling taking place on compartment doors and on the apparatus body, figure 5. Reviewing the history of the Engine 1 reveals an interesting evolution with these body parts.

There was similar paint failure on the compartment doors earlier in the life of this apparatus. Repair attempts (multiple) were problematic and unsuccessful. Finally, the compartment doors were replaced with new stainless-steel doors.

What makes this interesting is that the compartment door (right side of photo), the door hinge, and the door hinges screws are all stainless steel. The compartment body is aluminum.

The paint deterioration visible is heavier on the compartment door side than it is on the compartment body side. Since electrolysis take place between dissimilar metals and not between similar metals you would expect that there would be little or no paint bubbling on the compartment door. The electrolysis damage should be confined to the compartment body side.

The conditions observed here are a second indication that there is more going on with this apparatus than electrolysis from dissimilar metals.

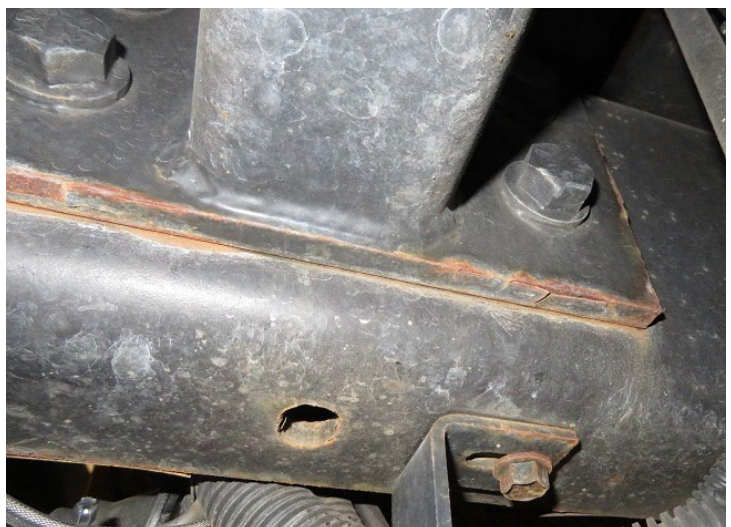
Figure 6 show a section of a chassis frame rail where a crossmember attaches towards the front the vehicle. There is some rust and minor paint delamination visible but overall the paint condition is good and the level of rust in line with the age of the vehicle. The white residue observed is from road deicing chemicals.

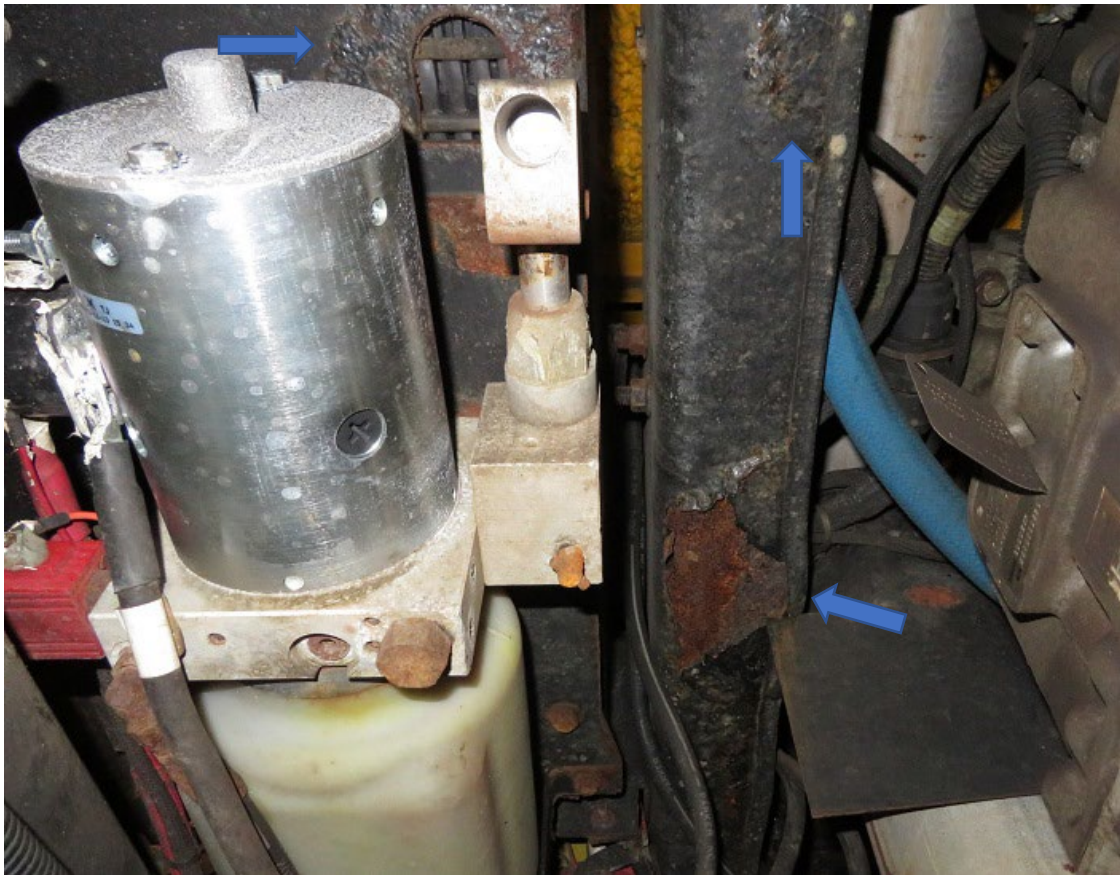
Figure 7

In figure 7 areas where there is paint blistering and missing paint which are caused by rusting conditions on both structural and non-structural chassis components. This area is towards the rear of the apparatus cab and you can already an increase in the amount of rust present as one moves toward the rear of the vehicle. Note the new pump assembly for the cab tilt assembly. Replacement was needed because the previous unit had corroded to the point of seizing and becoming non-functional.

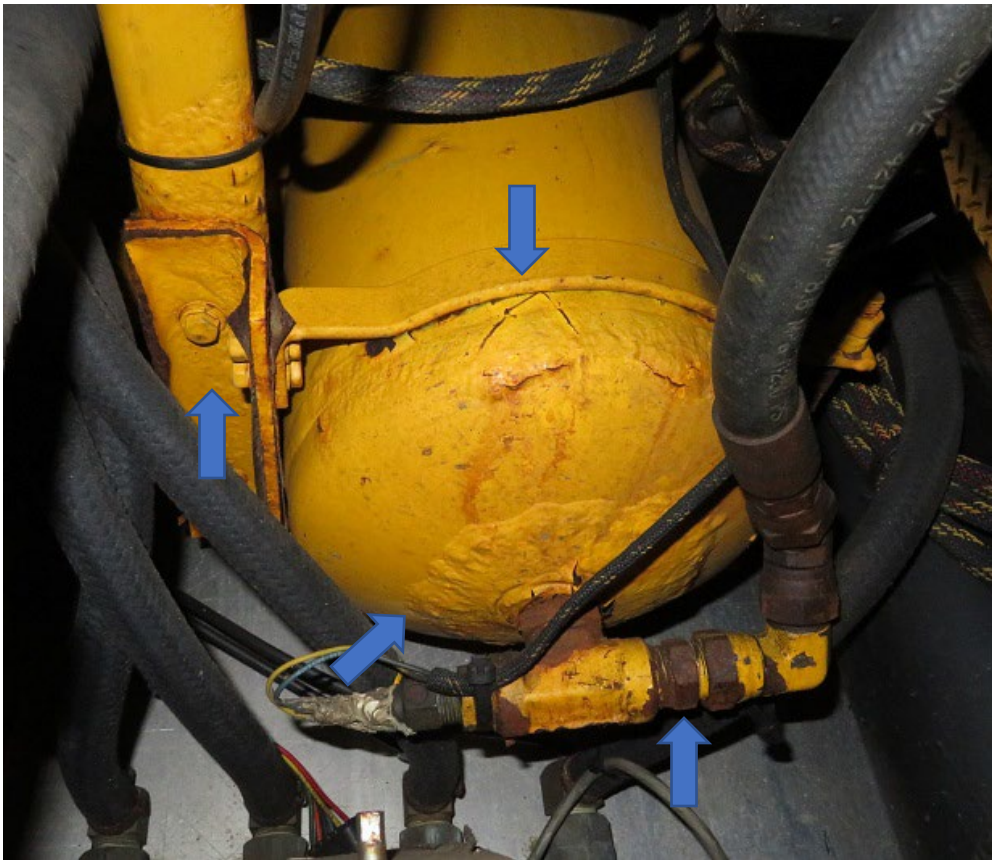
Figure 8

The air storage tank for the compressed air foam system, located in the pump enclosure, the mount bracket assembly, and the plumbing fittings all show heavy paint blistering, paint failure and rust conditions.

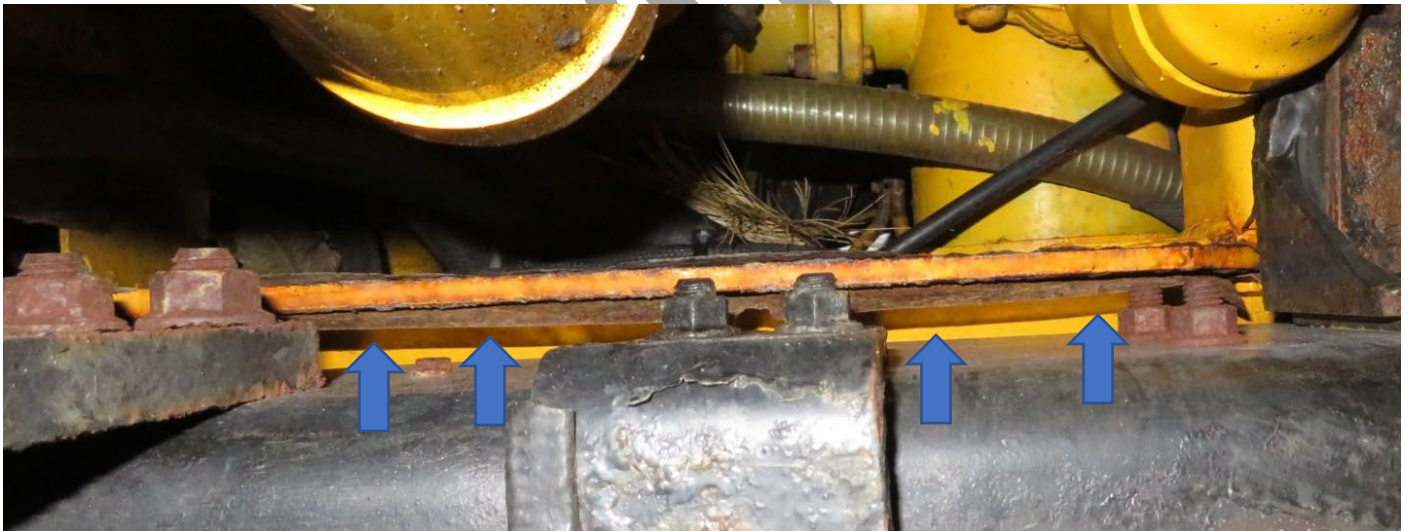
Figure 9 shows a good example of paint delamination. While it can be difficult to see in a picture the blue arrows point to the paint coming off the mounting bracket in a single sheet, almost like it is being pushed off metal from underneath.

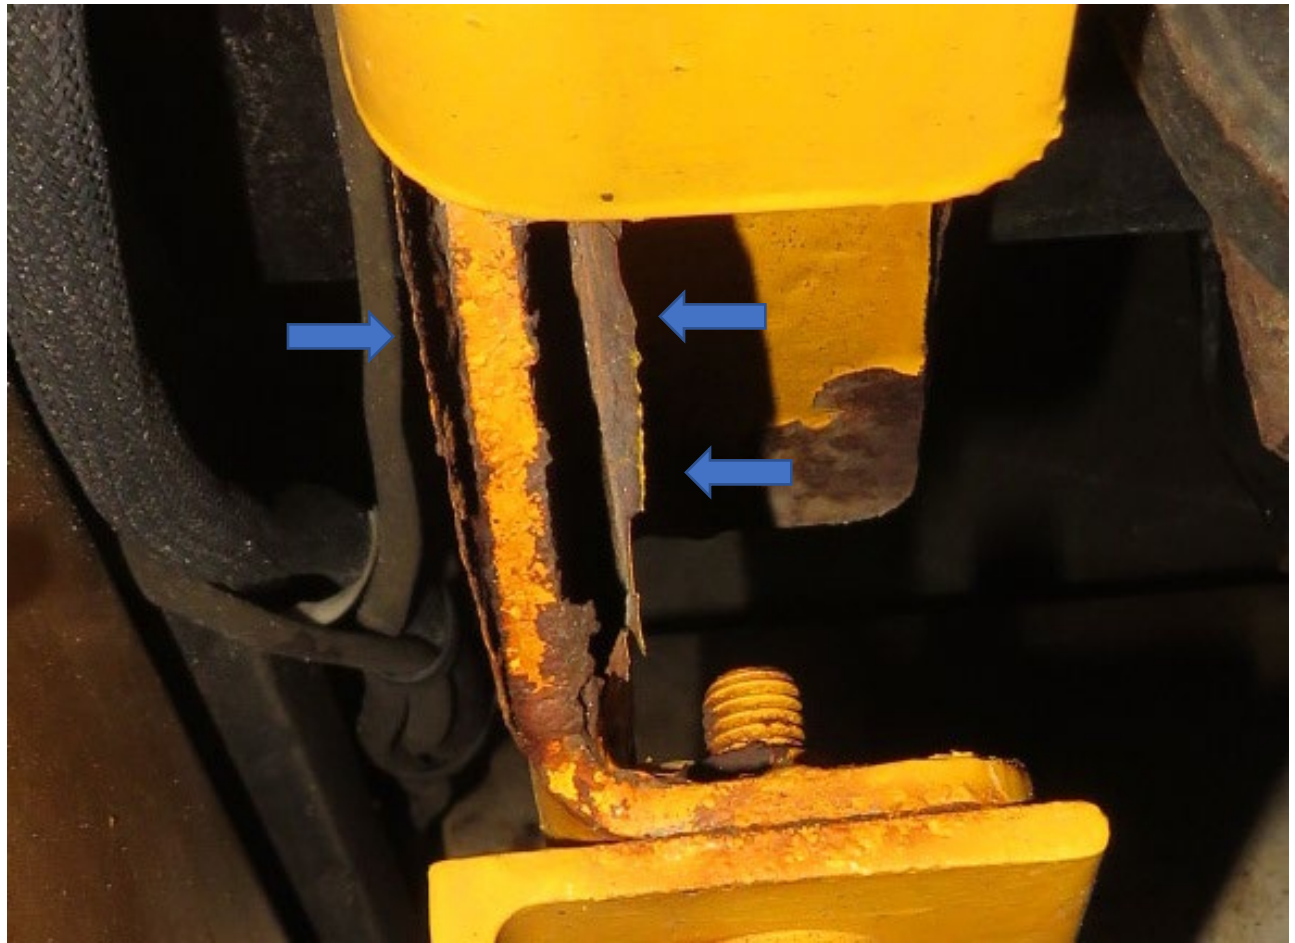
Figures 10 and 11 on the following page are close-ups of other chassis mounting brackets that give a better idea of what delamination and you can more clearly see the extent of paint failure when this process is taking place. Figure 10 shows delamination taking place on both sides of the same bracket.

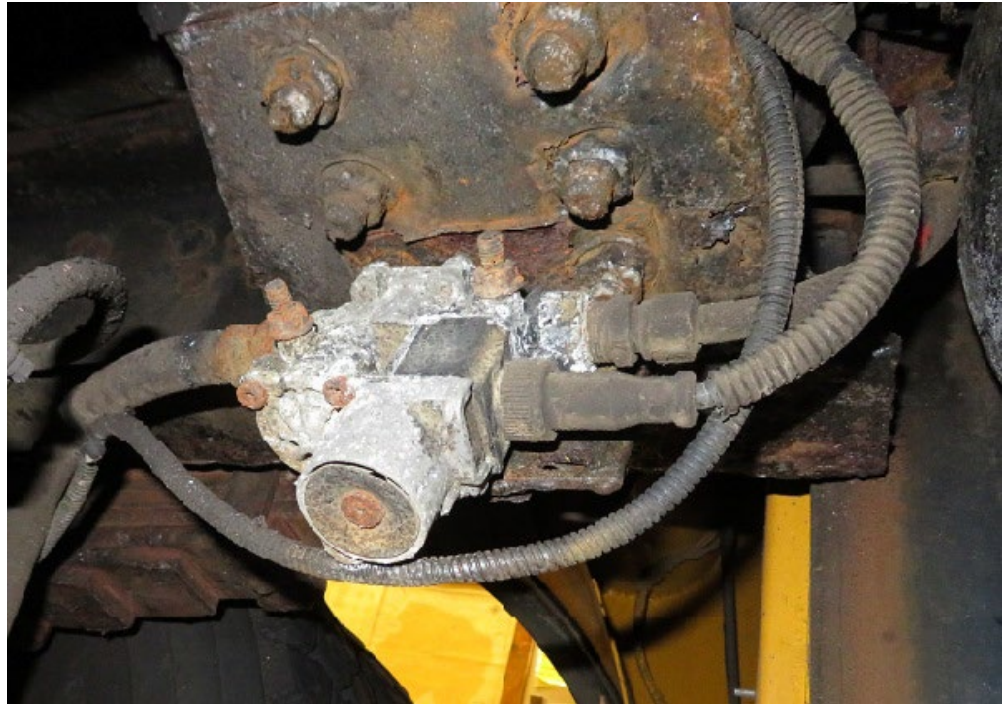
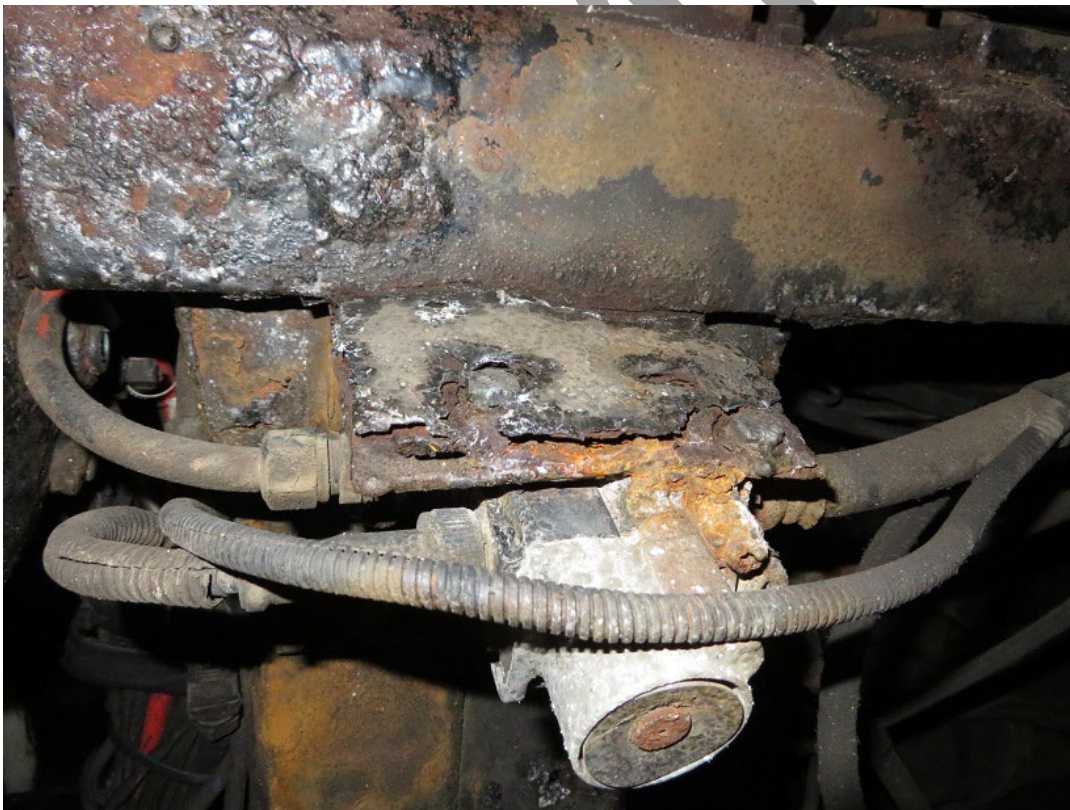
Figures 12 and 13 show a valve that is part of the vehicle's air brake system. The valve housing, mounting bolts and the crossmember plate above the house all show heavy corrosion. Figure 12 you can see that the mounting plate for the air valve is being virtually destroyed by rust and corrosion. There is also heavy paint blistering visible on the chassis crossmember.

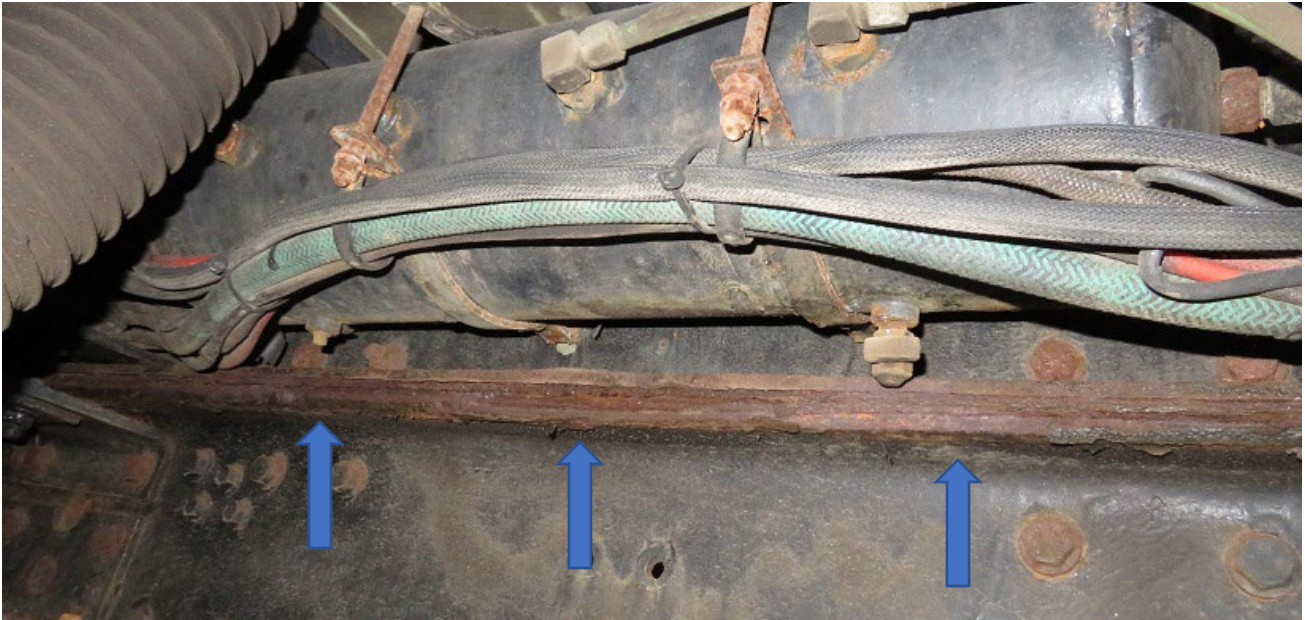
Along the rear of the apparatus chassis the chassis rails are stacked vertically. This was done because this vehicle is a 4WD unit and that significantly raises the front of the vehicle in order to match that and make the vehicle sit level the rear has to be raised. Figure 14 shows rust jacking taking place between the stacked chassis rails.

As steel rusts it expands, when the steel parts that form a fixture or component are closely mated the rusting and expanding steel begins to push the mated steel surfaces apart this is referred to as rust jacking.

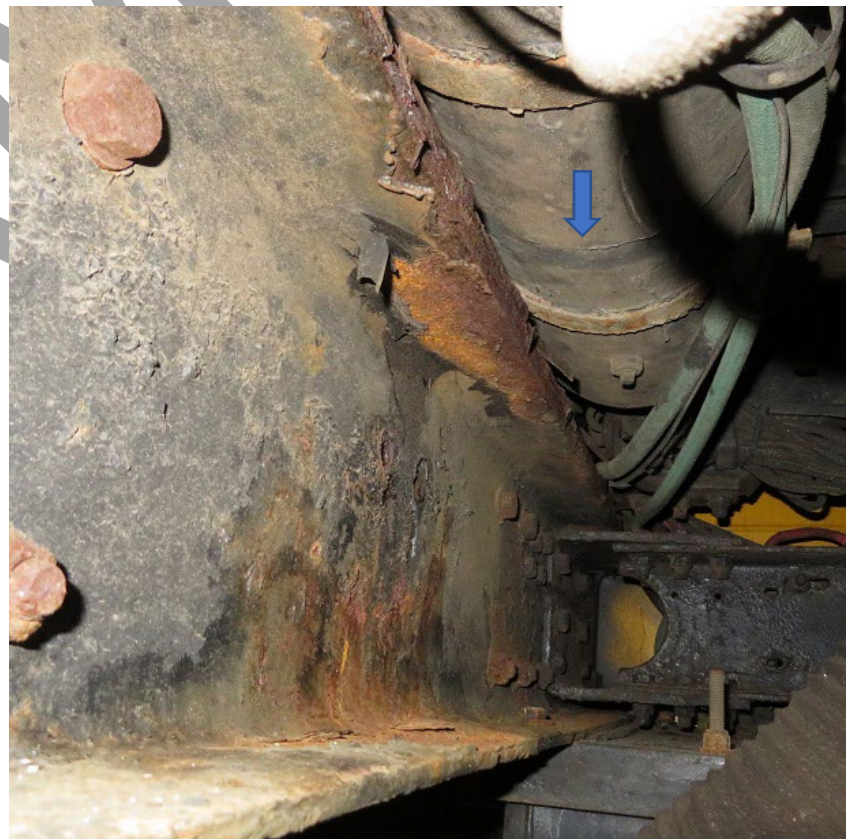
Figure 15

In figure 15 you can see a chassis rail and the corrosion along the top and bottom flanges and the web. On the chassis air tank in the top of the photo its mounting brackets are both rusting and there is a band around the middle of the tank, blue arrow, where there was at some point another bracket.

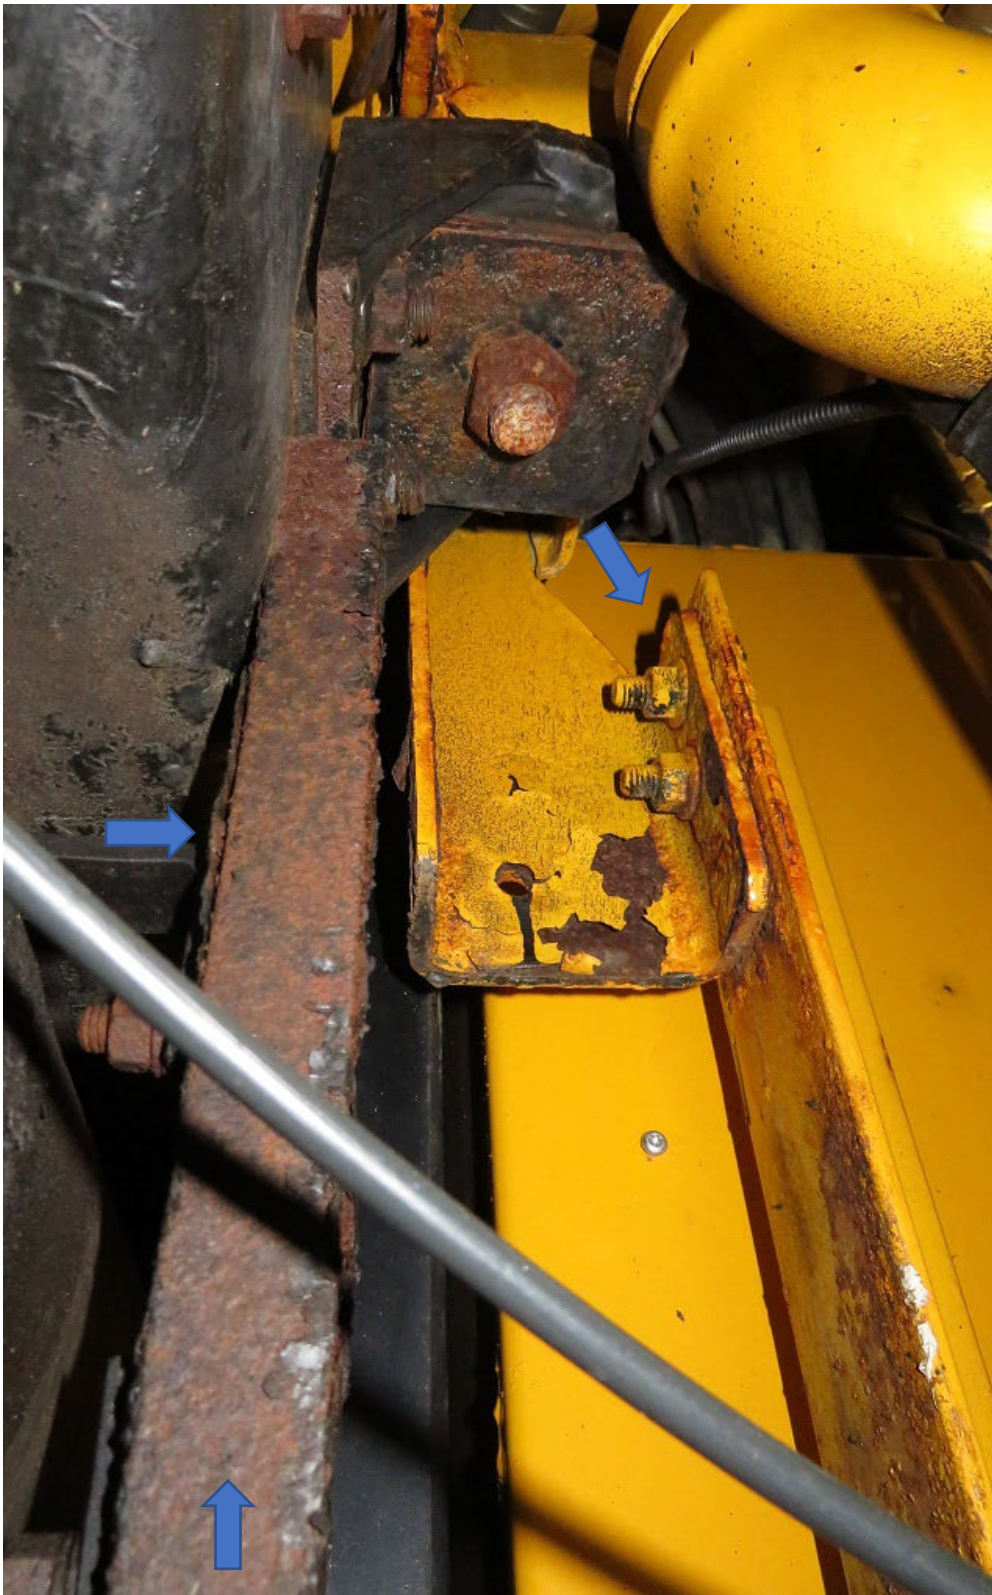
Figure 16 shows an upright support in the pump enclosure/body area. The corrosion along left side support has completely stripped the paint from one side of the square tube and there is delamination along the side. The yellow supports show heavy corrosion.

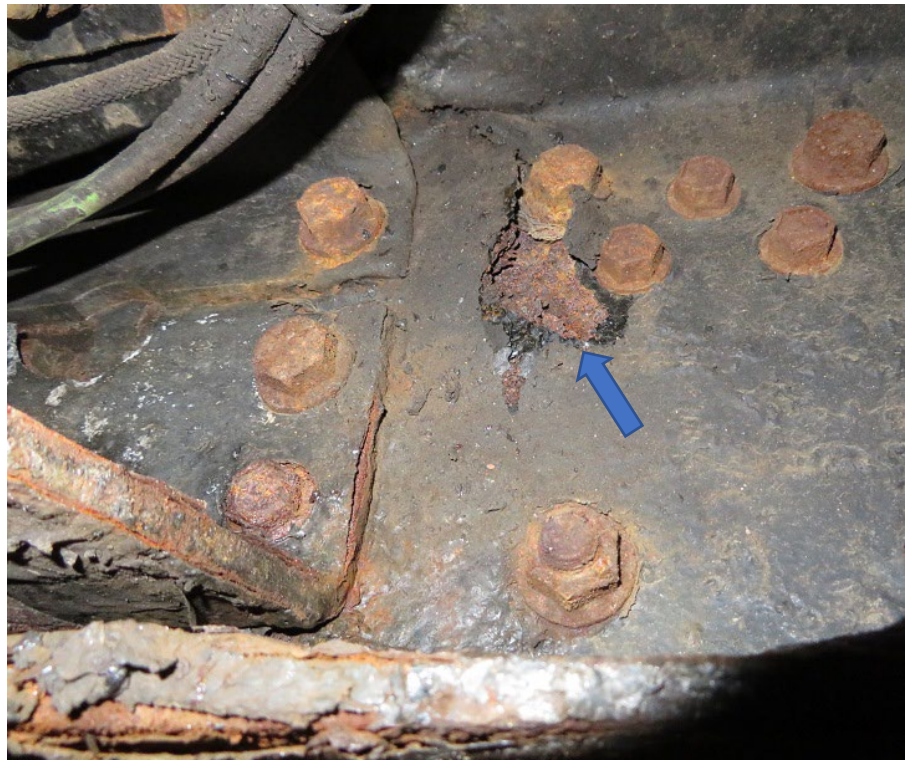
Figure 17

A chassis section, figure 17, where there is heavy rust deterioration (blue arrow), extensive paint blistering, some delamination and substantial rust and corrosion.

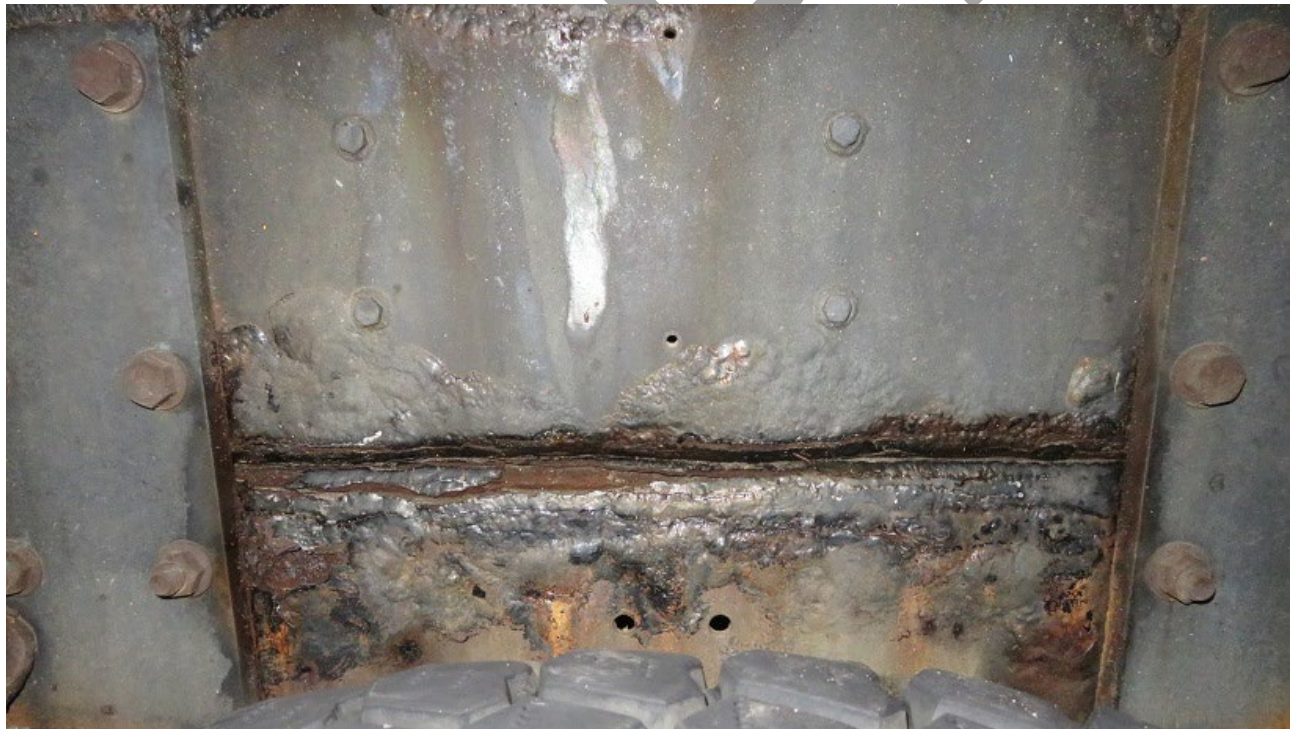
Figure 18

Looking into the back of a rear axle wheel well, figure 18, you can see broad side of the stacked chassis rails and the support plates that hold them together. The lower rail is the one that the rear suspension and axle is mounted to. Also visible is paint blistering and rust corrosion that is seen on many areas of the chassis.

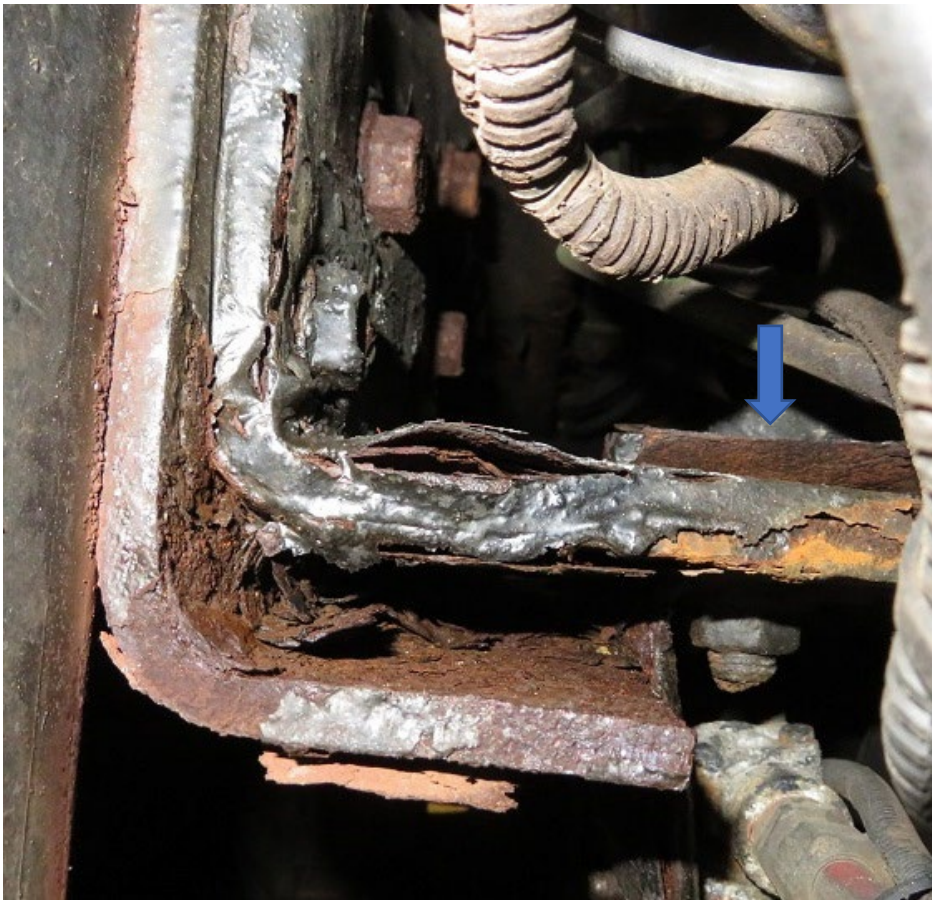
Figure 19

Another section of the vehicle chassis, figure 19, showing delamination, blue arrow, and rust deterioration. Like conditions observed on other areas of the chassis this is more extensive than what you would expect to see on a vehicle of this age.

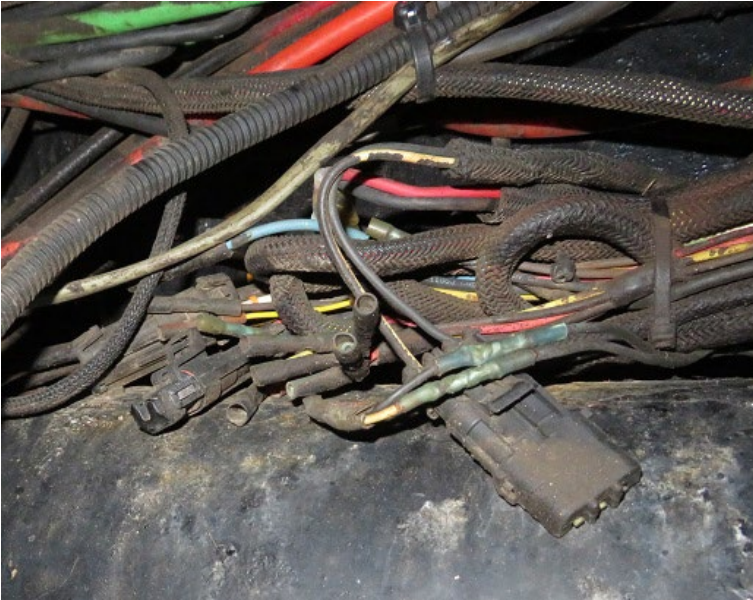
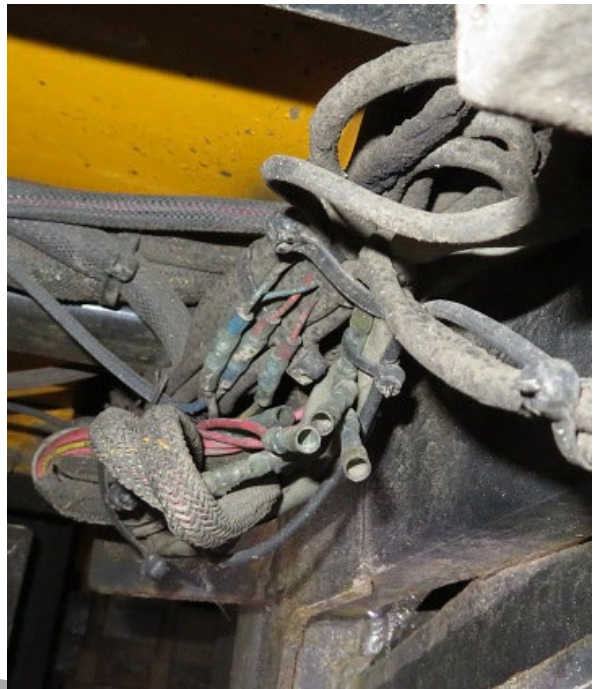
Figures 20 & 21 show two (2) electrical connection points where the wiring is worn or not properly terminated. This type of wiring/connection was not uncommon when Engine 1 was built. It is not something that you would find on apparatus today.

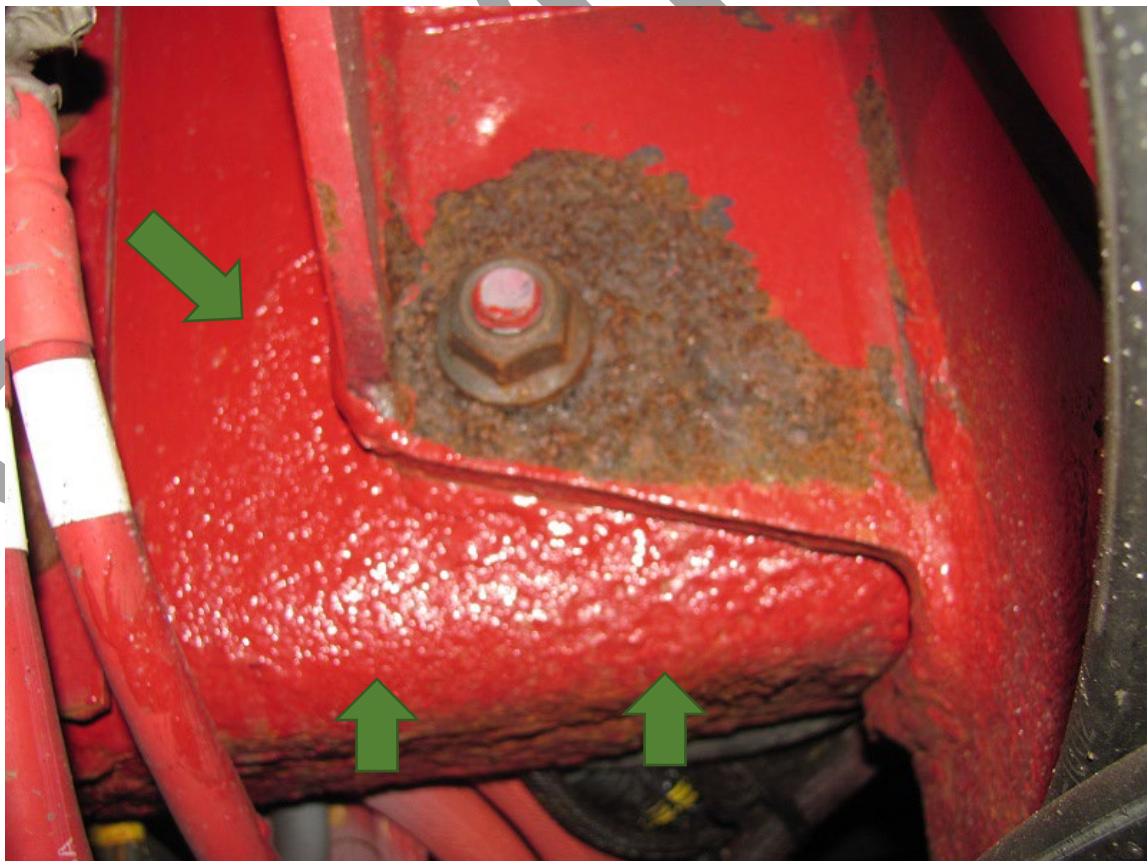
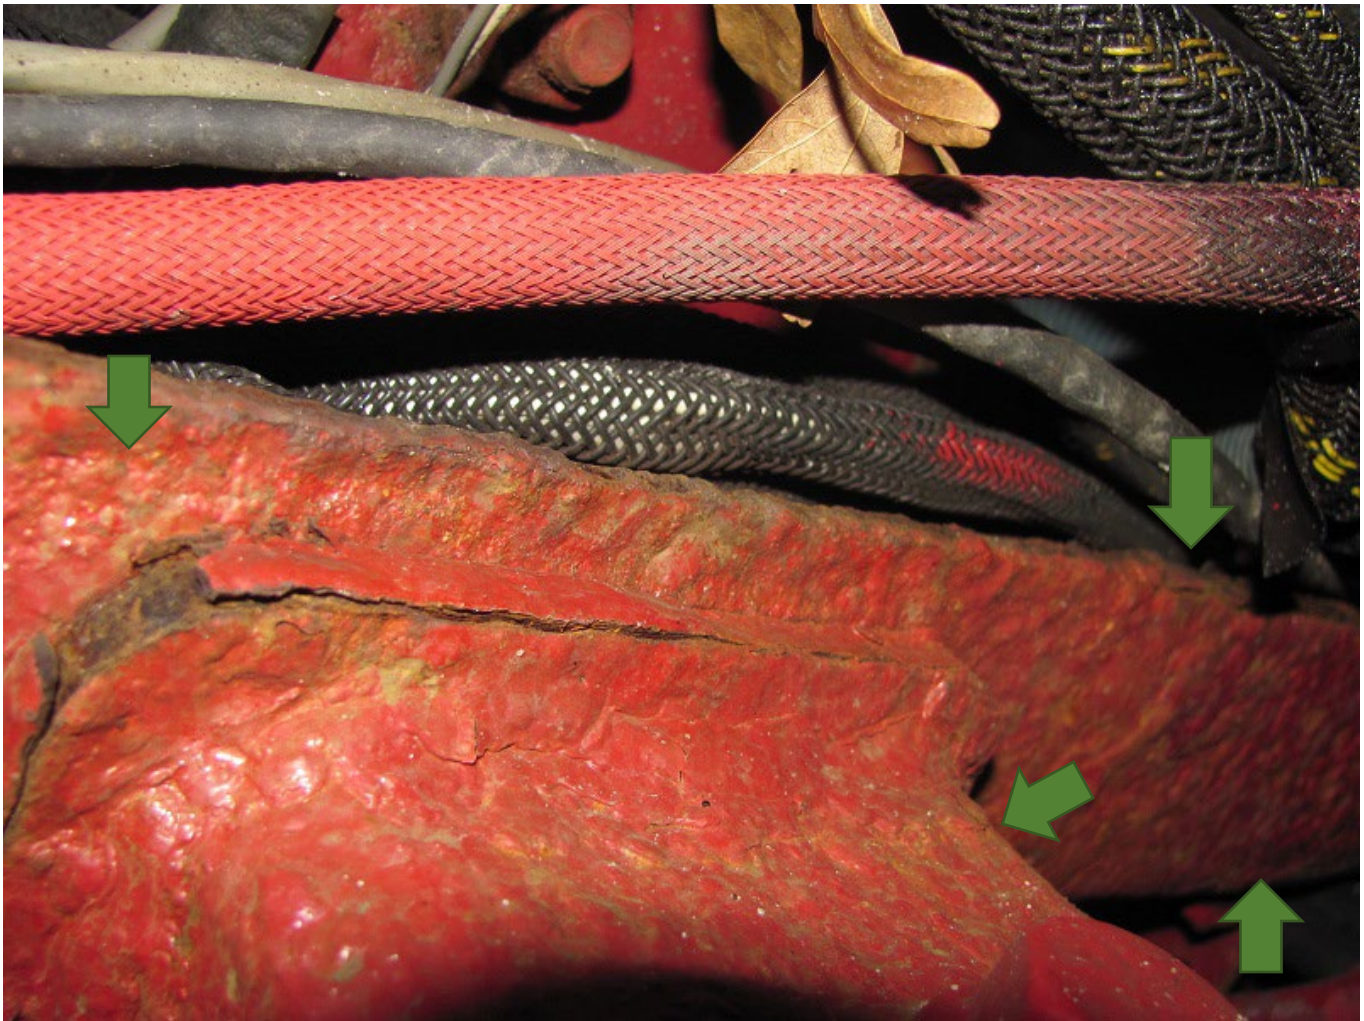
Is it a good decision to refurbish this vehicle without rewiring it? No, in my opinion. Figure 22 & 23 show a 2002 pumper made by the same manufacturer as Engine 1. This vehicle was refurbished because of rust and deterioration similar to Engine 1. It's a body off refurb with the chassis rails being cleaned and repainted, not replaced. A few years after the refurb the rust and deterioration is back as bad as if not worse than prior to the refurb. The green arrows highlight areas where the chassis paint appears rough in texture these are areas of rust and delamination prior to the refurb.

Absence of clearly defining and correcting the causes of the rust/corrosion problems only succeeded in moving the problems around the chassis assembly. In a fairly short period of time the fire department found itself in the same position they were in a few years earlier.
