**Tower Ladder – Quint In-Service  
Inspection (Sample)**

**Any Town Fire Department**  
**Any Town, U.S.A.**

**Big Red Trucks Fire Apparatus Consultants Inc.**  
Tel: 1-866-723-1075

**Tower Ladder 1**

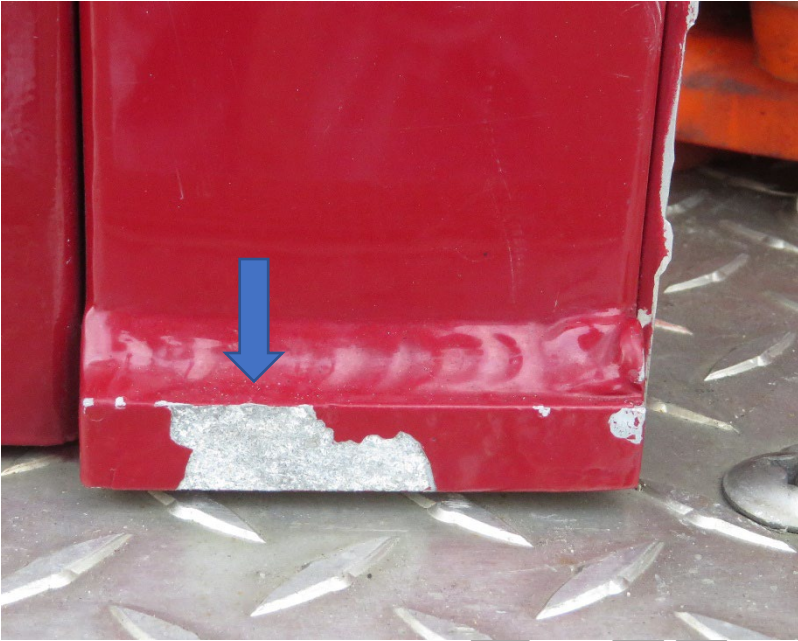
Figure 2

Both appear to be in good condition structurally. There is “white” rust around the vehicle in varying degrees. “White” rust is aluminum deterioration caused by atmospheric conditions similar to what causes steel to rust, figures 2 & 3.

This type of deterioration can be seen at various locations around the cab and body assemblies of aluminum apparatus. This can include but would not be limited to; wheel wells, compartment door hinges, mounting for grab handles and light fixtures.

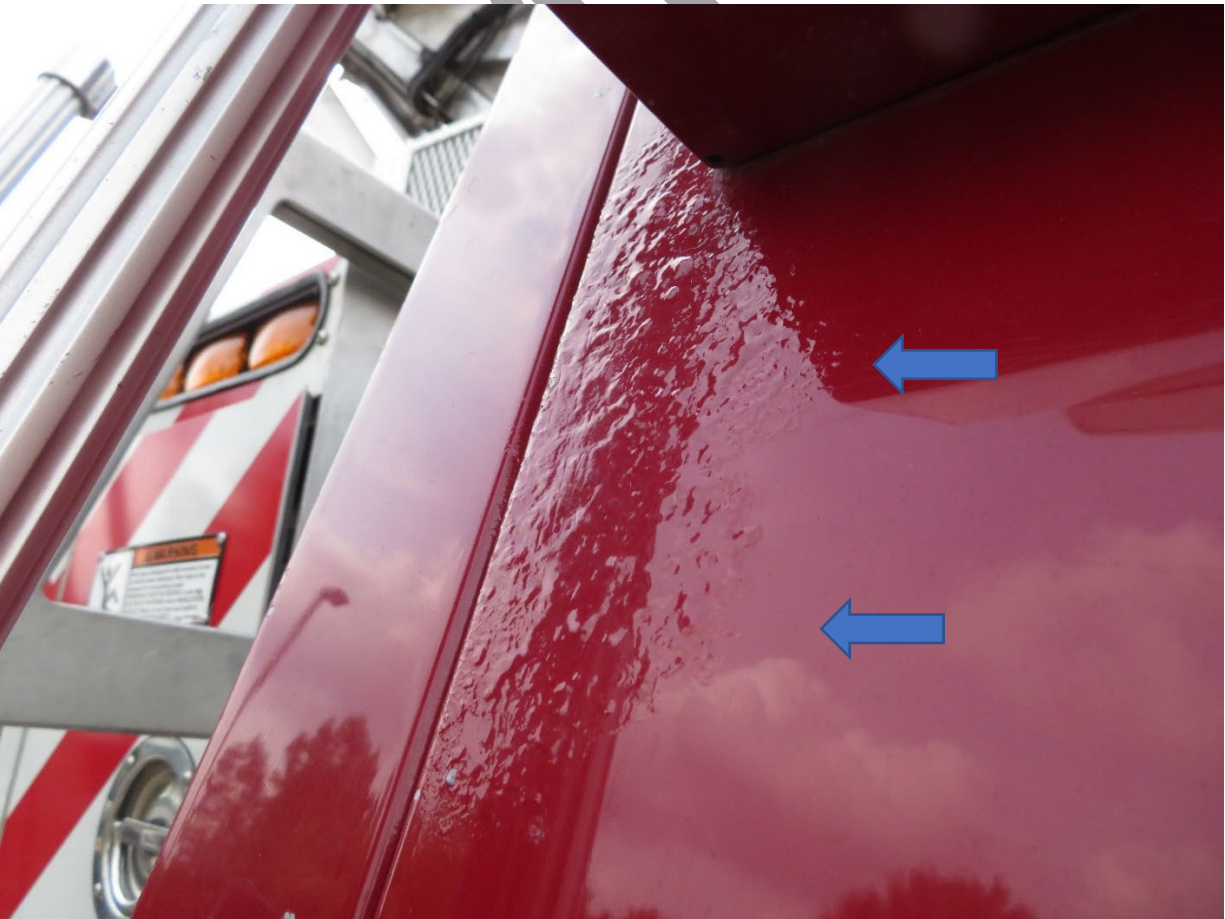
Figure 3

White rust is most often caused by a process referred to as electrolysis and reaction when two dissimilar metals come into contact with each other, such as when stainless steel bolts are used to mount accessories on an aluminum truck body. There are chemical coatings available and some physical barriers that greatly reduce and, in some cases, eliminate this condition. White rust can also be caused when water or other foreign chemicals particularly road deicing chemicals come in contact with the aluminum body material. The condition can grow under the paint as shown by the blistering of the paint in figure 3.

While white rust is generally not as severe as rust in steel, it spreads quickly causing more cosmetic damage than structural damage to the vehicle. White rust can and in some case does cause structural damage, but that condition does not appear to be an issue on this apparatus at this time. White rust is time consuming to repair and if the root cause is not corrected the condition will return.

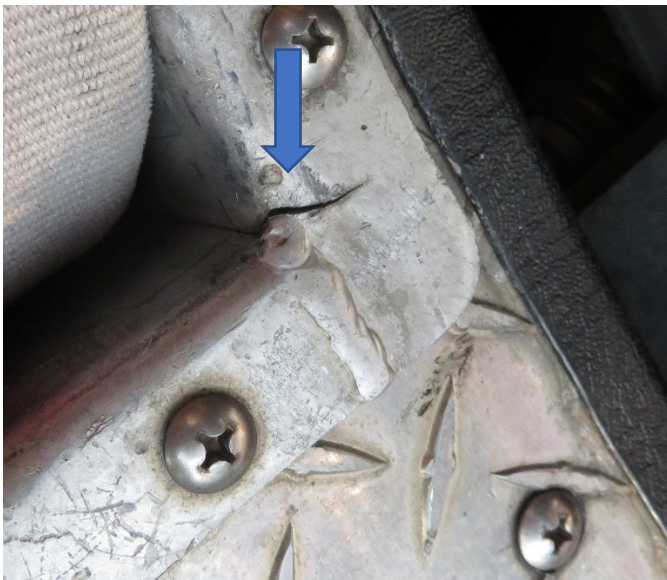
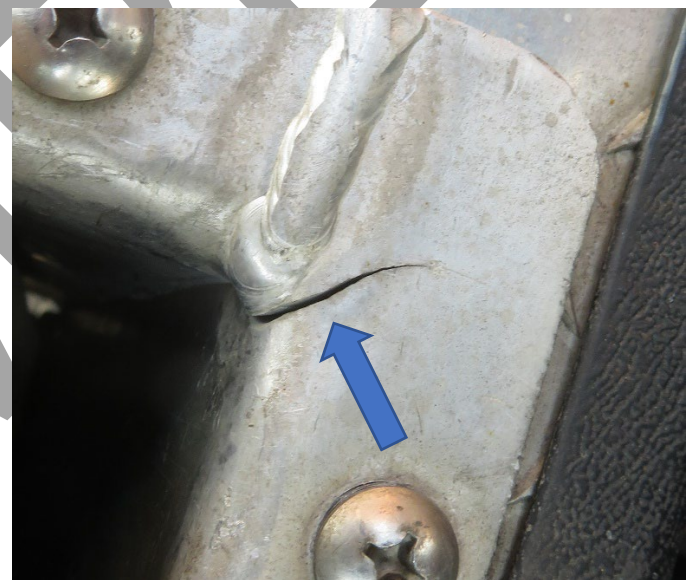
There is some cracking in each the front bumper hose troughs as shown in figures 4 and 5. There is no cracking in the gravel shield surrounding any of these troughs so this condition may just be related to chassis flex and not a cause for concern. The structural support for the front bumper assembly should be thoroughly inspected for structural integrity when it is disassembled.

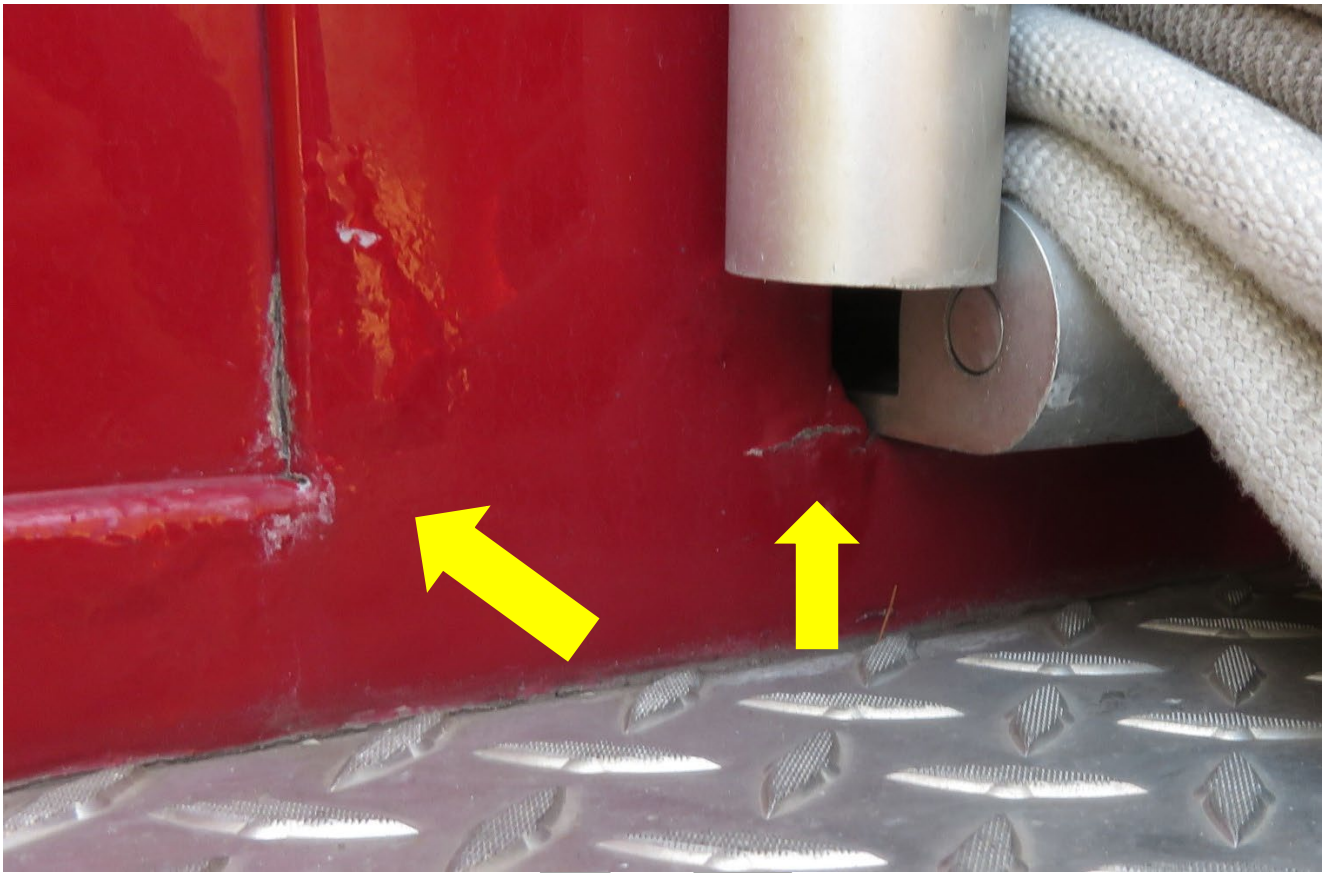
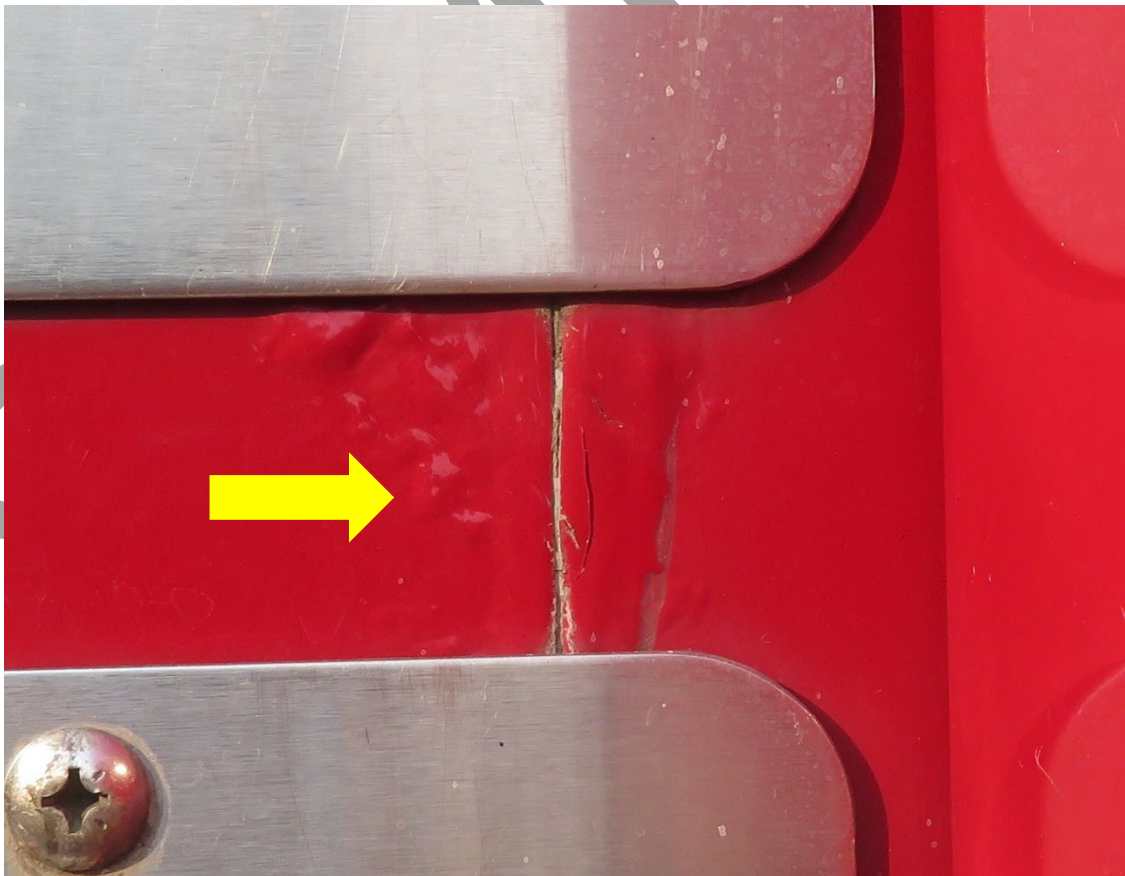
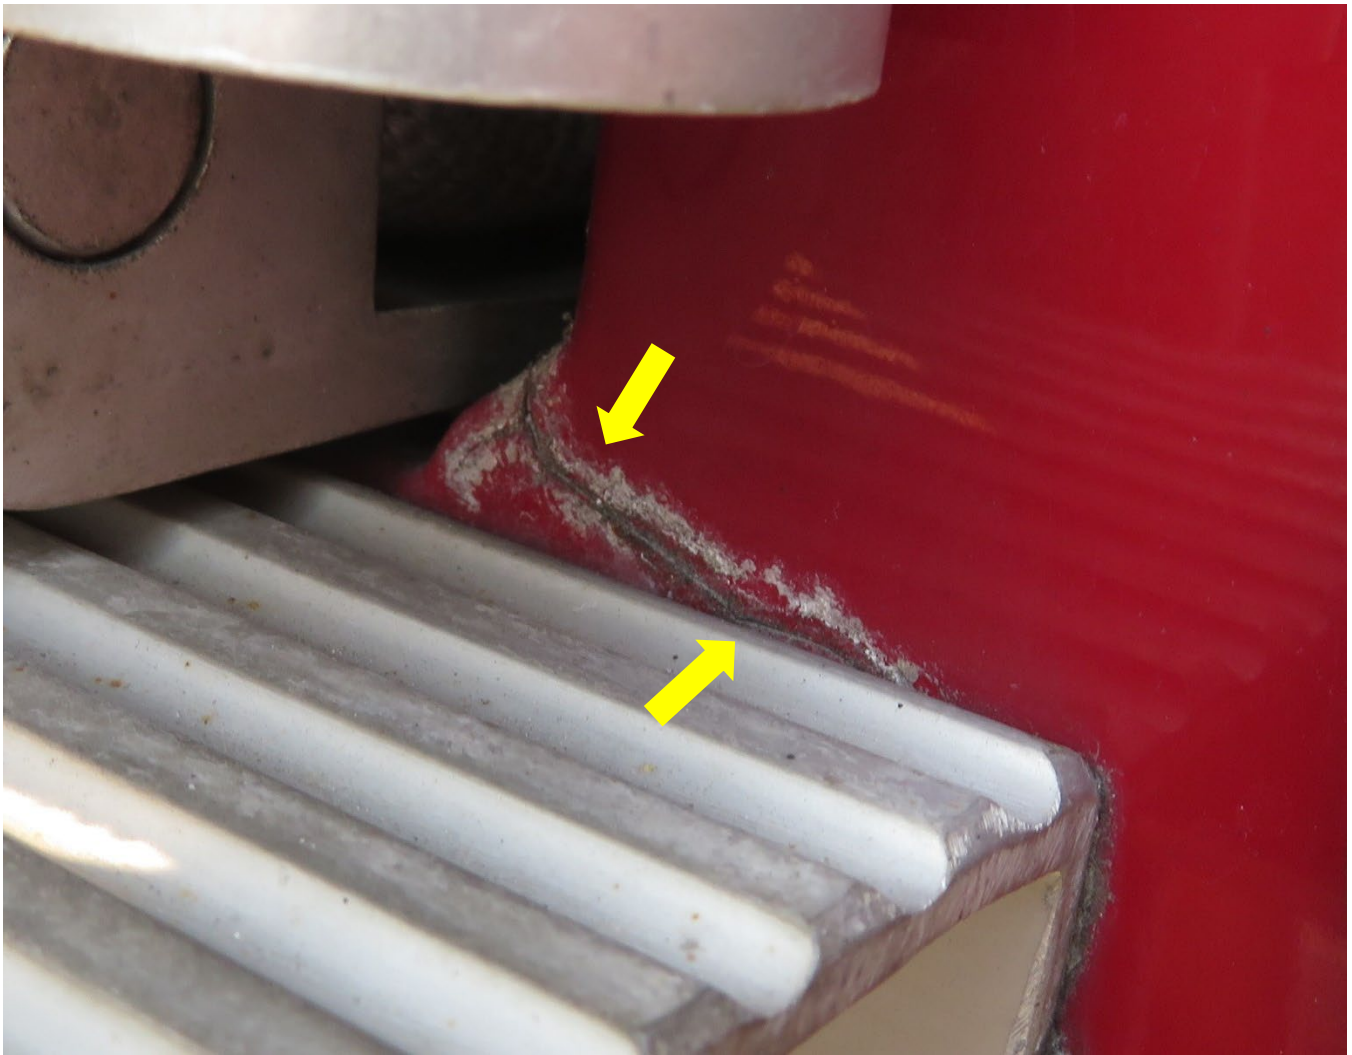
There is some paint blistering, white rust evident, and cracking in various locations of the pump enclosure as detailed in figures 6, 7, and 8. This is in locations where cracking has occurred on other Blaze Fighter vehicles. The conditions observed on TL-1 are not as severe as other vehicles inspected but these will need to be addressed and corrected during any type of refurbishment.

These cracks are in locations where the structural skeleton is joined and welded. The issues causing these cracks are generally not catastrophic and repairs can usually be done without major complications. But this is a prime example of the types of issues discovered during the refurbishment process. The severity of the defect(s) and the scope of the repair(s) needed to correct the issue(s) that are discovered are not clear until the unit is disassembled and a complete picture of what is going on is able to be seen.

The cracking in the pump enclosure detailed is not as extensive as seen in similar apparatus but these conditions almost always are worse than meets the eye. While I do not think it is a reason not to continue to explore the refurbishment option keep in mind that there are some issues here that will need to be addressed.

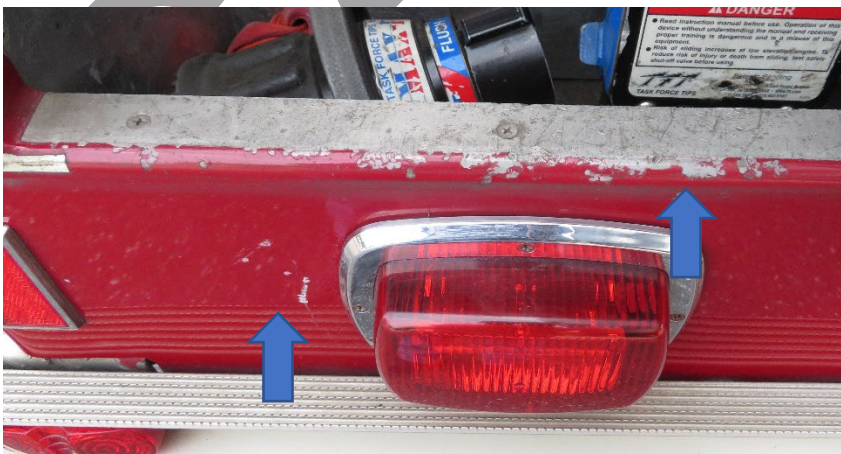
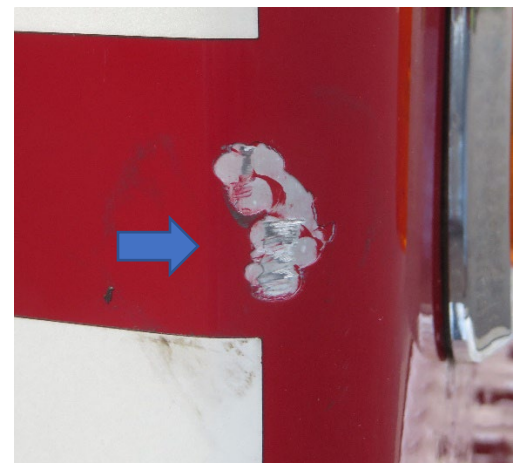
There is paint damage around the compartment door sills from deploying and stowing tools and equipment, paint nicks and scratches from operations and driving all in line with age and use of the vehicle and cosmetic, figures 9 and 10. These can create entry points for water and road chemicals that may ultimately make the problems worse.

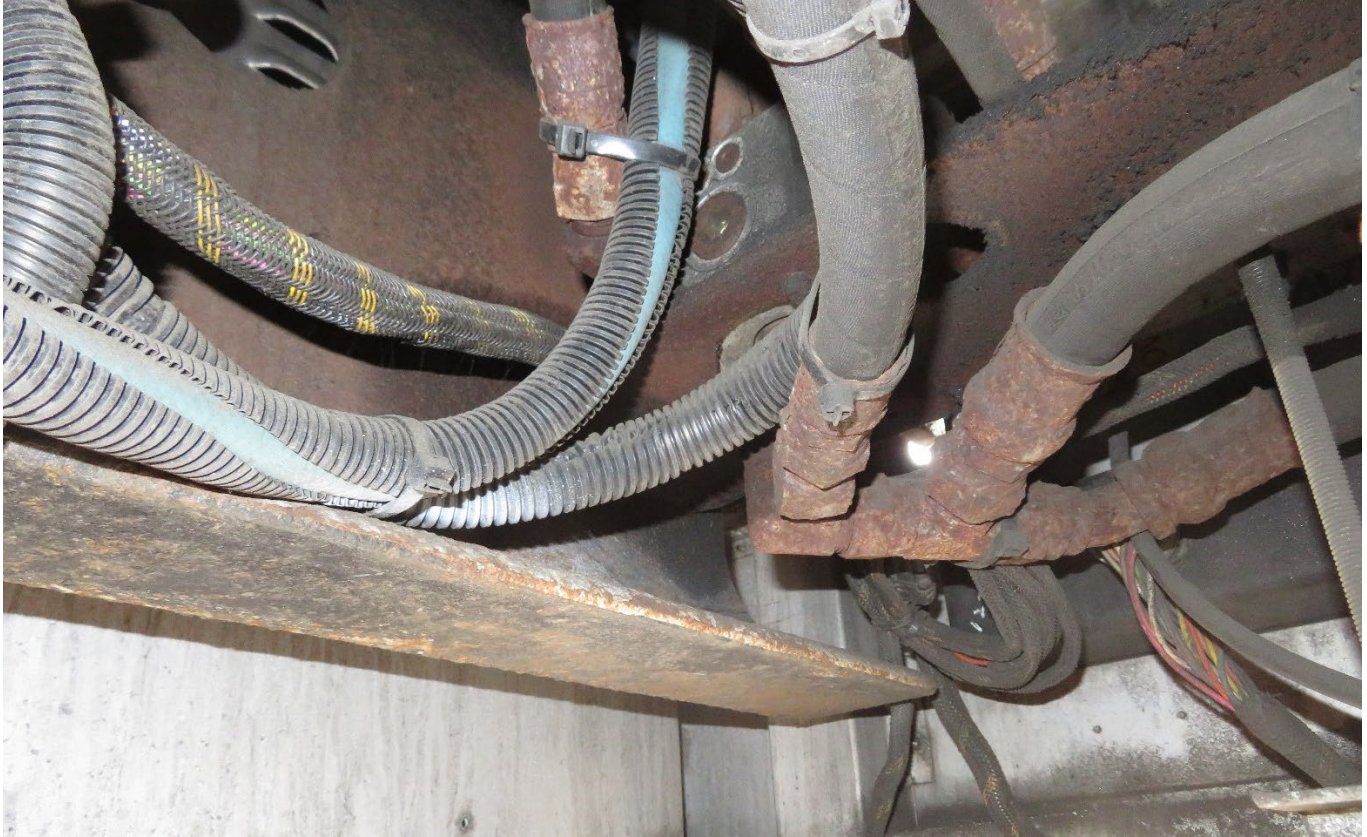
Figure 11

The tower ladder support structure for the aerial device which is intergral to to the chassis and the chassis both appear to be in good condition. None of the rust visable on the chassis assembly appears to be be severe or structural and is in line with age of the vehcile and its service life, figure 11. There was no rust jacking visable on the chassis assembly.

The chassis assembly will need a much more thorough inspection when the compartment body is removed from the vehicle when visibility and access is much greater but initial observations are that the foundation of this apparatus is a good candidate for refurbishment.

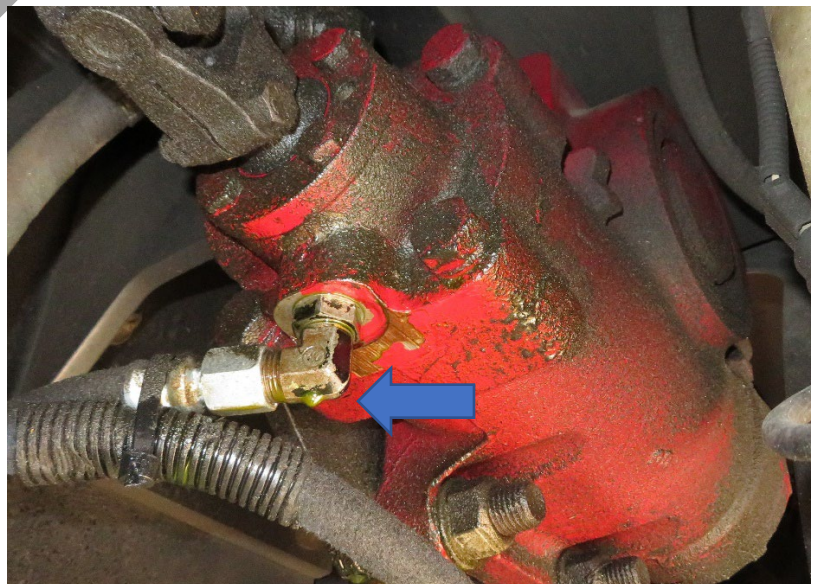
Figure 12

The steering box has a class 3 leak, figure 12.

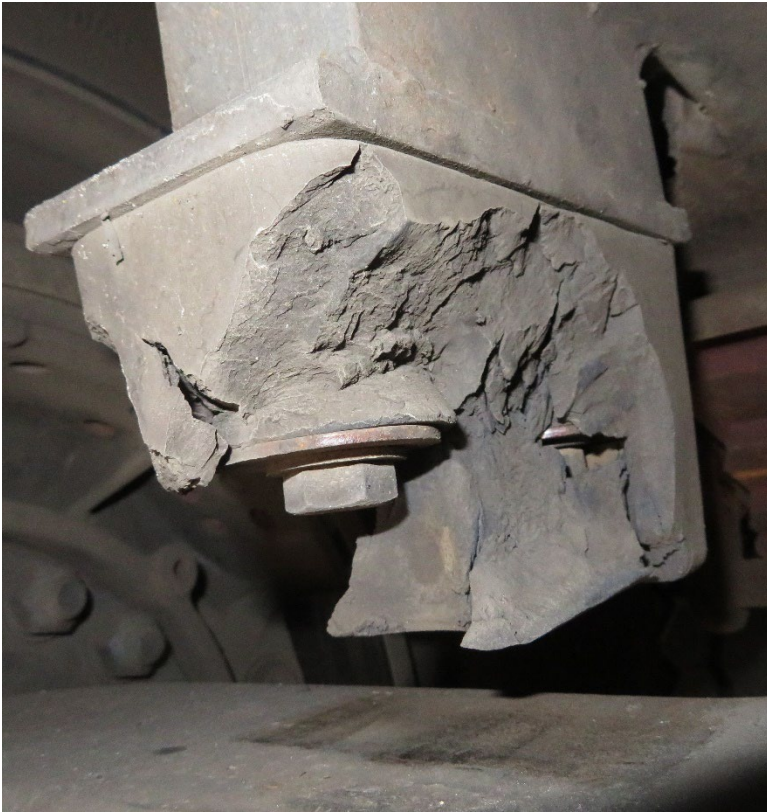
Figure 13

A bump stop for the rear suspension is in need of replacement, figure 13.

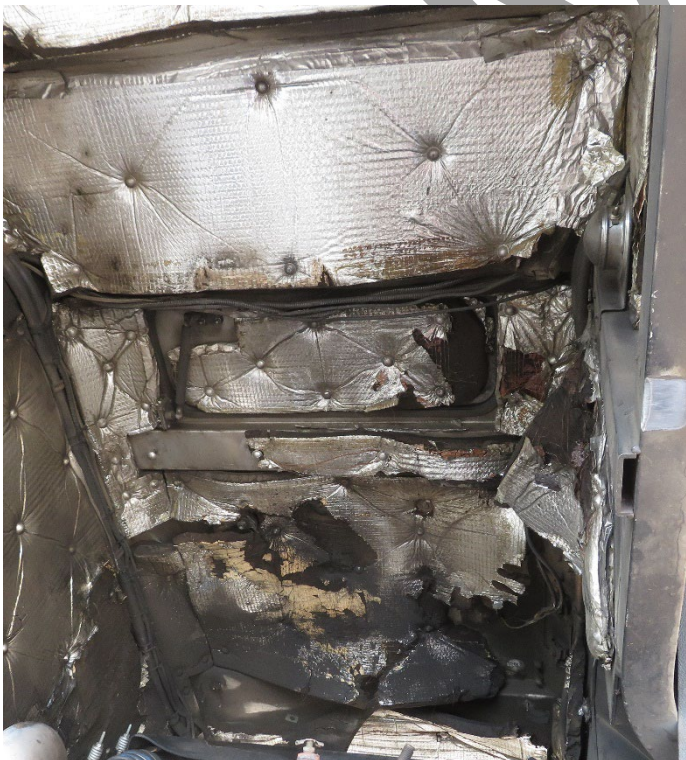
Figure 14

Figure 14, deteriorating insulation/sound deadening material in the engine compartment.

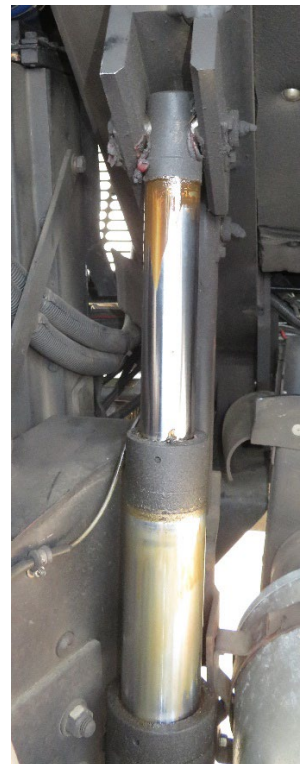
Figure 15

Bad wiping seals indicated by the oil residue left on the extending portions of the hydraulic cab lift cylinder, figure 15.

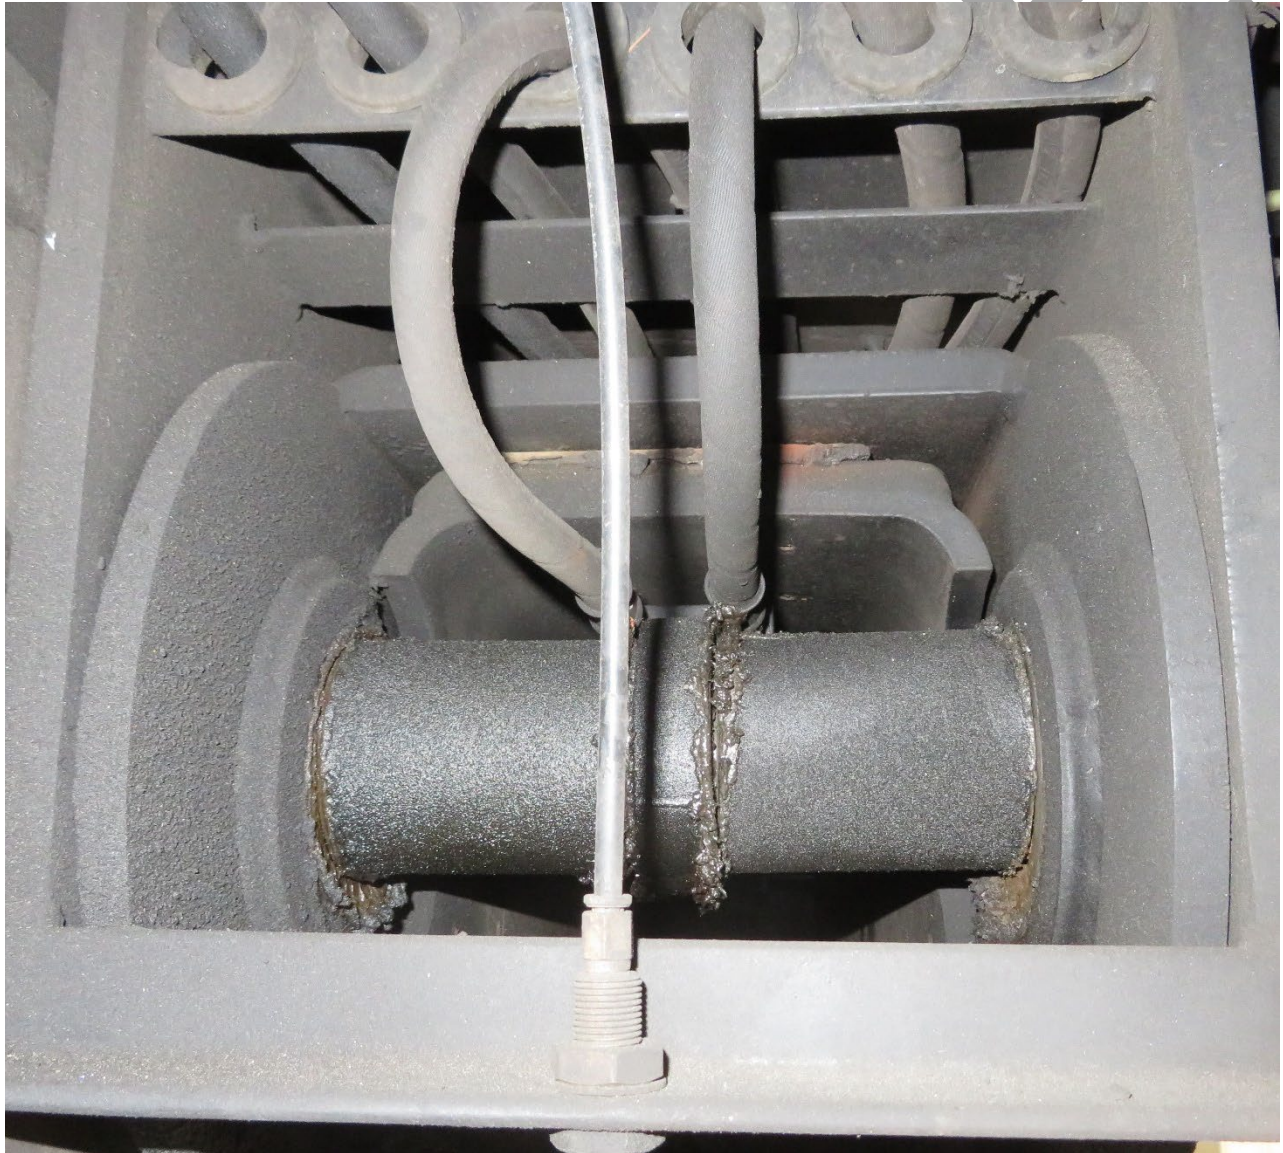
**Figure 16**

Outrigger tube, dry and free of any hydraulic leaks.

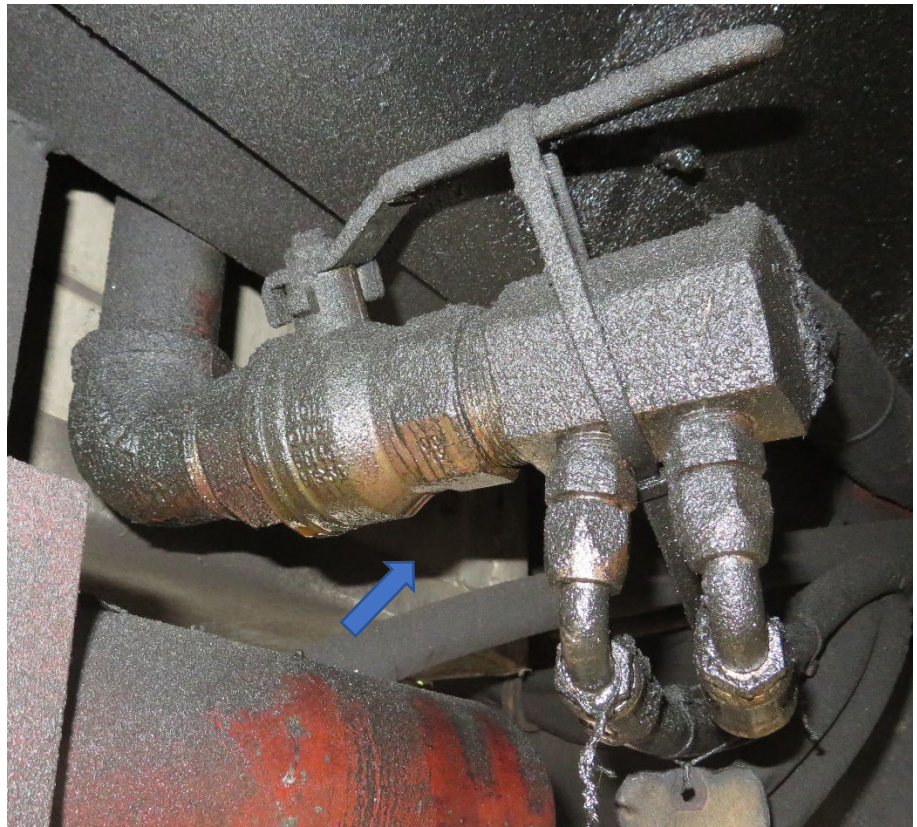
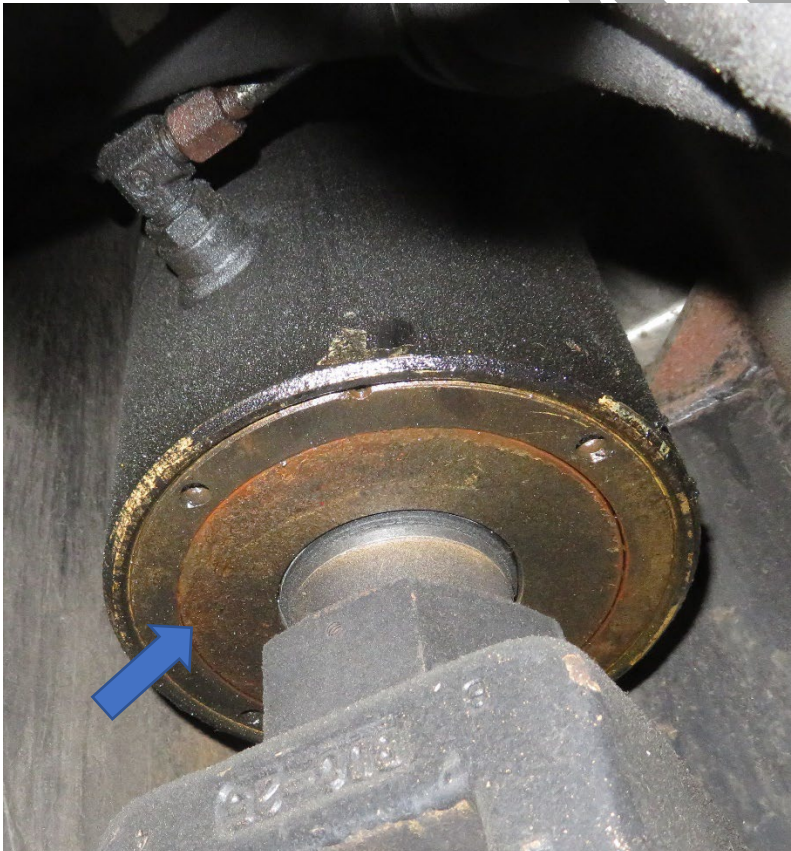
A hydraulic shut-off valve assembly wet with hydraulic fluid, figure 17. Figure 18 down pressure assembly, wet with hydraulic fluid.

None of the hydraulic leaks observed in the aerial hydraulic system were severe or need immediate attention. They should be monitored and addressed if they leakage shows any signs of worsening.

During a refurbishment of a vehicle of this kind all of the hydraulic cylinders should be rebuilt, all of the flexible hydraulic lines should be replaced and any of the electric over hydraulic wiring should be replaced. Rebuild or replacement of hydraulic controls, actuators, shut off valves, rigid lines and the rotational motor should be done according to the recommendations of the aerial manufacturer.

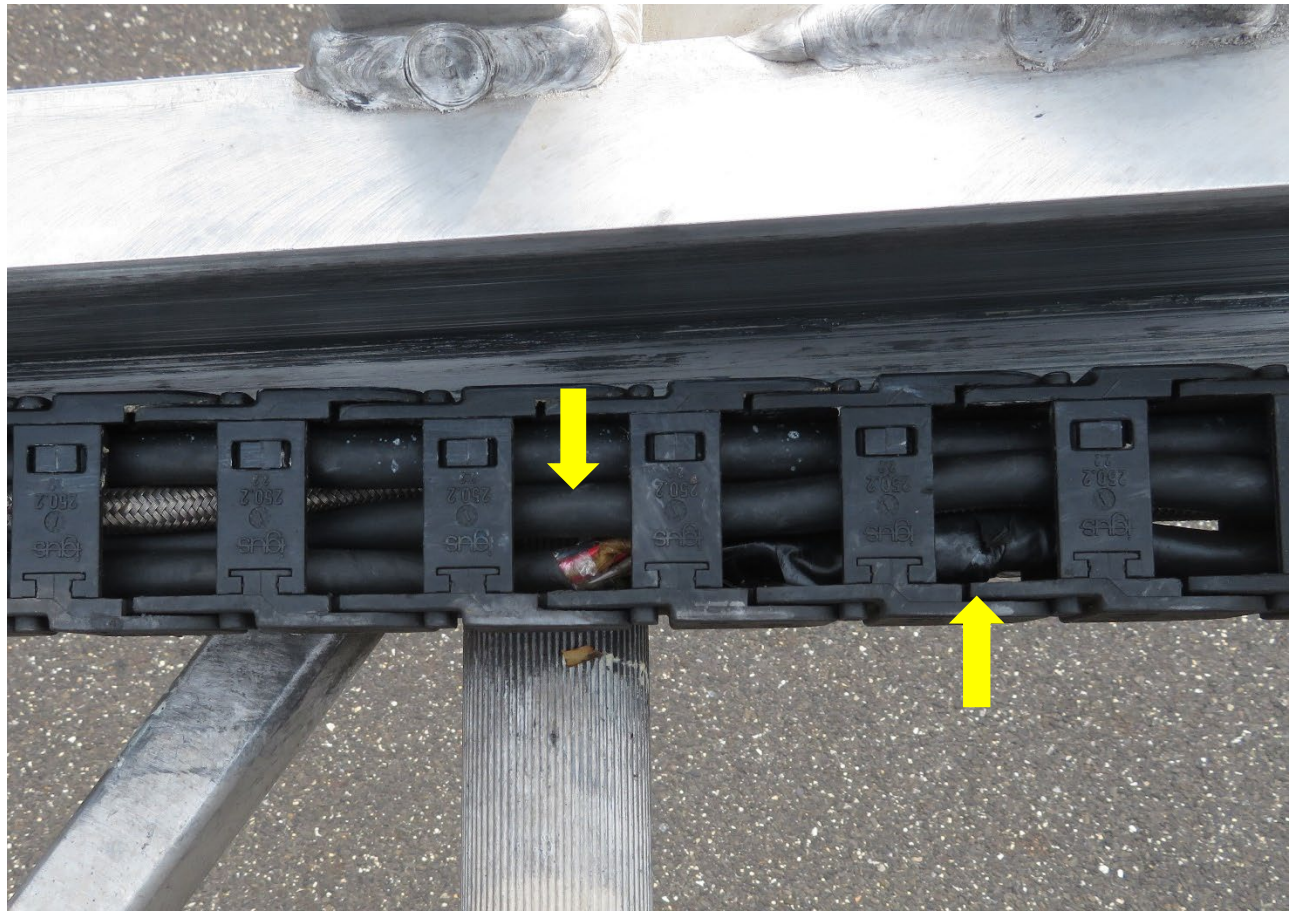
Figure 19

The wire repair noted in the UL inspection reports, figure 19. Wiring and hydraulic lines between the turntable pedestal and the personnel platform should be replaced as part of refurbishment.

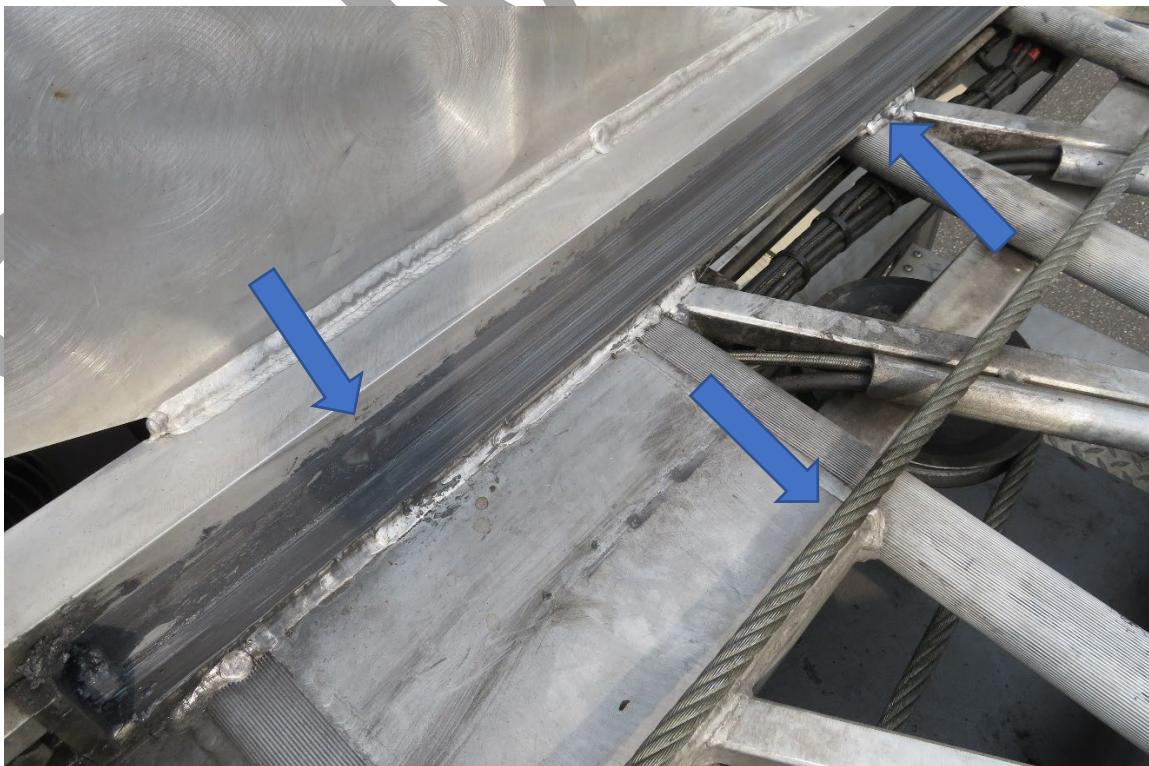
Figure 20

Side area, figure 20 show the grease build up and some through annual cleaning of the aerial device and it components is critical to reliable aerial device performance. This also helps reduce wear and tear on the aerial device and its components minimizing expensive repairs and downtime.

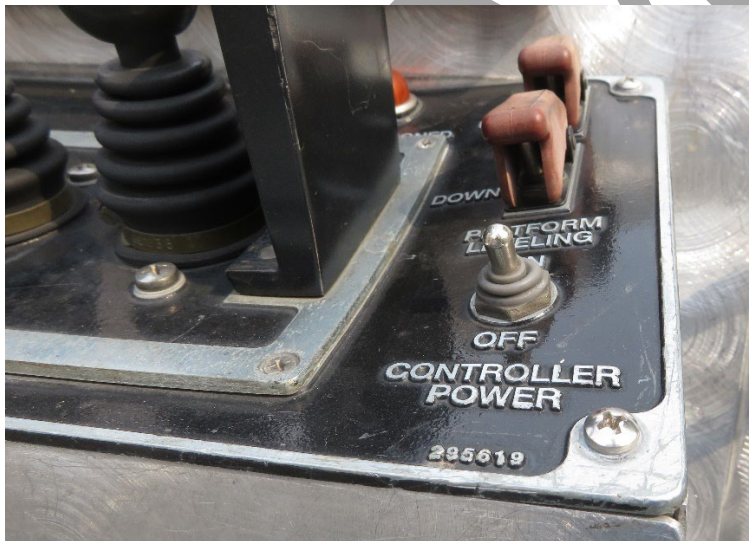
Figure 22

Both the platform operation station, figure 22 and the turntable pedestal operation station, figure 23 show signs of being bent and this should be addressed during refurbishment.
